**2016 BELLE ISLE
COMPREHENSIVE
HYDROLOGIC
ASSESSMENT**

REPORT OBJECTIVES

In response to tasks 2A and 2B of the Lake Okonoka Habitat Restoration project, this report aims to gain an understanding of the current hydrology on Belle Isle specific to the +/- 200 acre natural area referred to as the wet-mesic flatwoods forest (flatwoods).

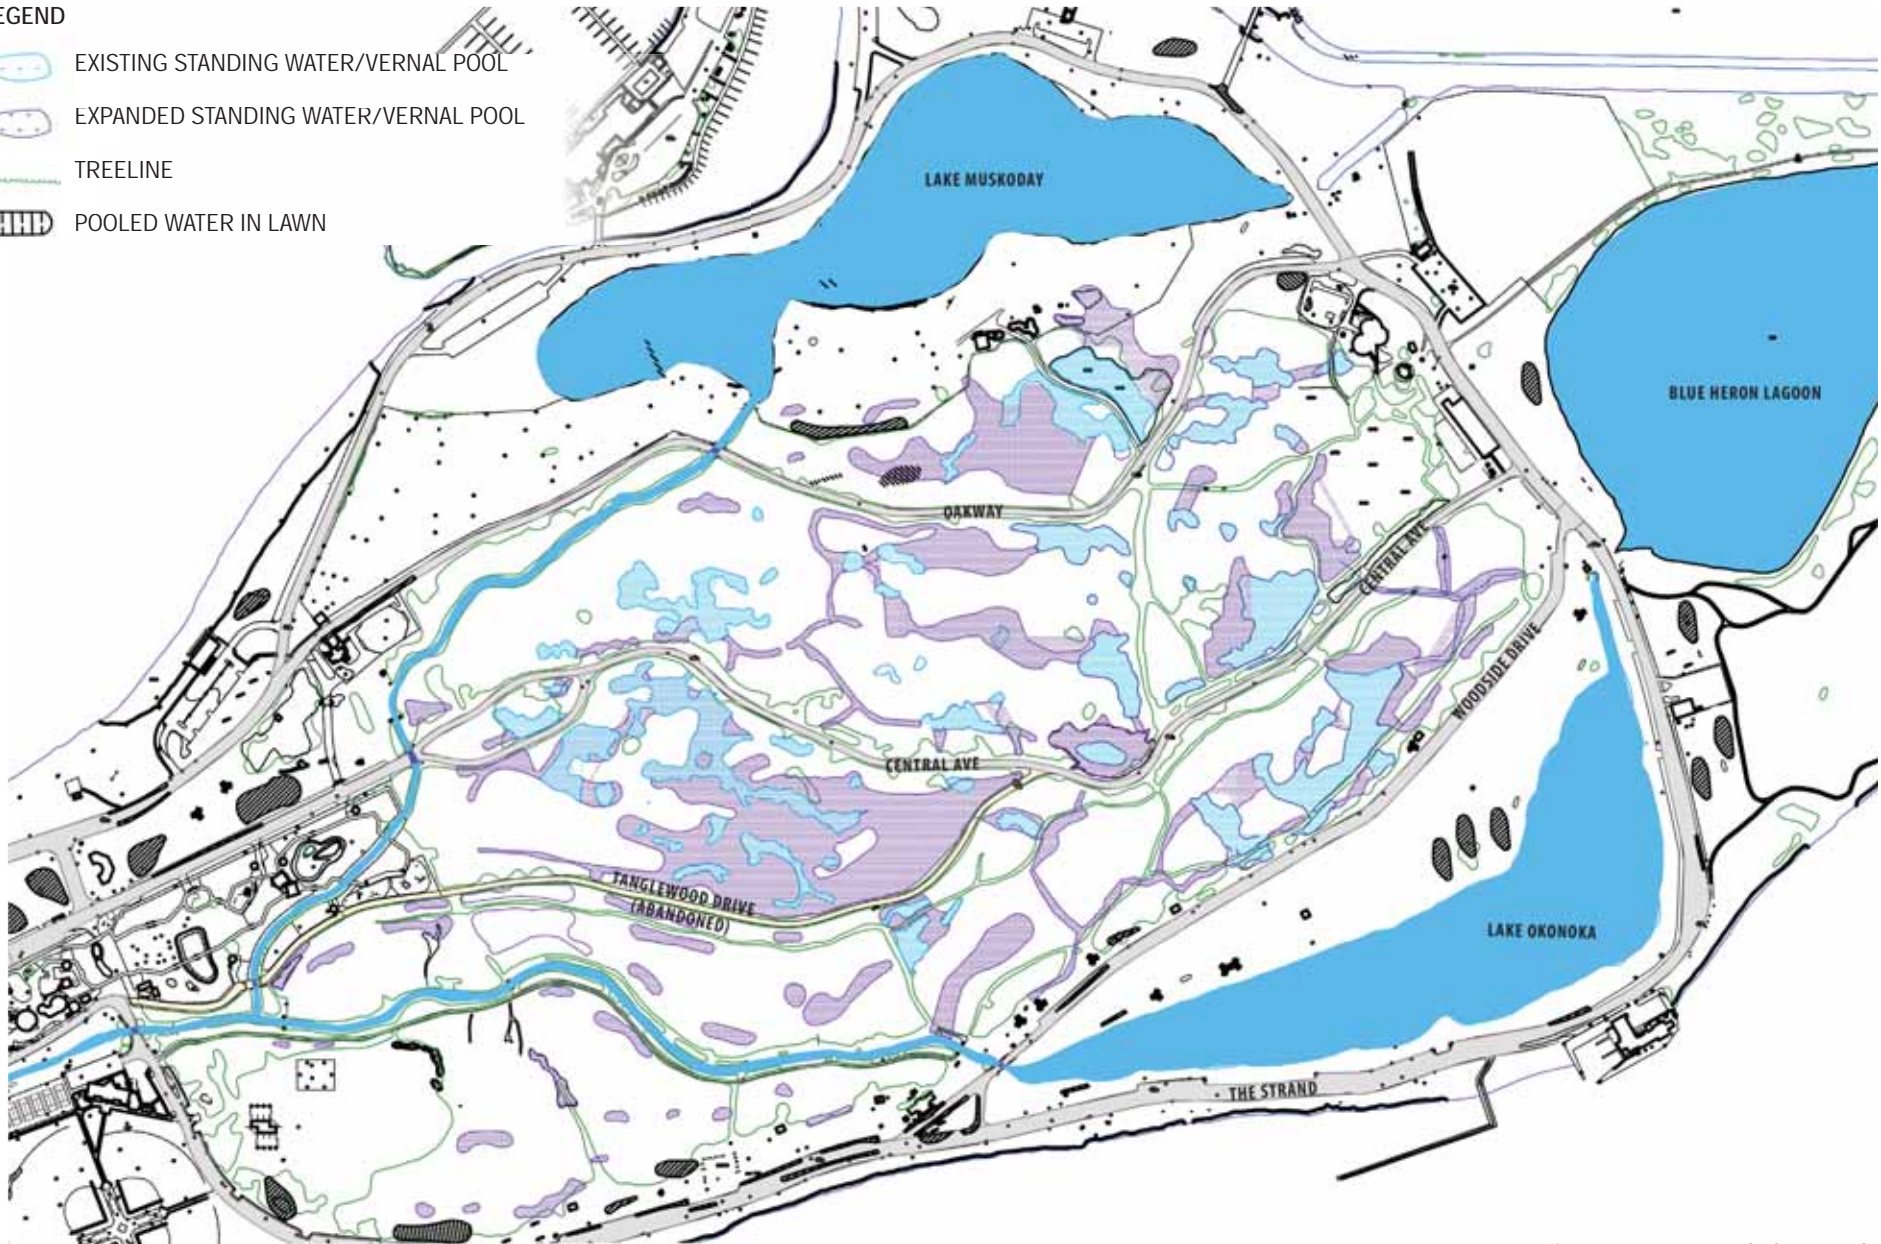
Figure 4. Forest Hydrology-Pools

General observations of the pools indicate that some areas currently are holding too much surface water, while others are not holding enough and that the causes vary based on location within the site. Pools that appeared to be in balance included water adapted tree species with flared collars (*buttresses*) at water- or ground-level and the absence of understory vegetation. This is an indication of a persistent condition that may have extended back to the late 1800's before park construction. At pools where excessive water was present, some tree species were under stress or dead, remaining trees did not appear to have flared collars and persistent standing water was observed through late summer and early fall. The understory was

observed to be dense with large colonies of ash (*Fraxinus spp.*), maple (*Acer spp.*) seedlings or spicebush (*Lindera benzoin*) suggesting that this condition is more recent. Areas that were excessively dry contain no standing water, even though topography suggests that it should and ditching appears to be the cause of this condition. Tree health was considered good but Amur honeysuckle (*Lonicera maackii*) was observed to be the most abundant understory species and is an upland species that may have taken hold due to draining.

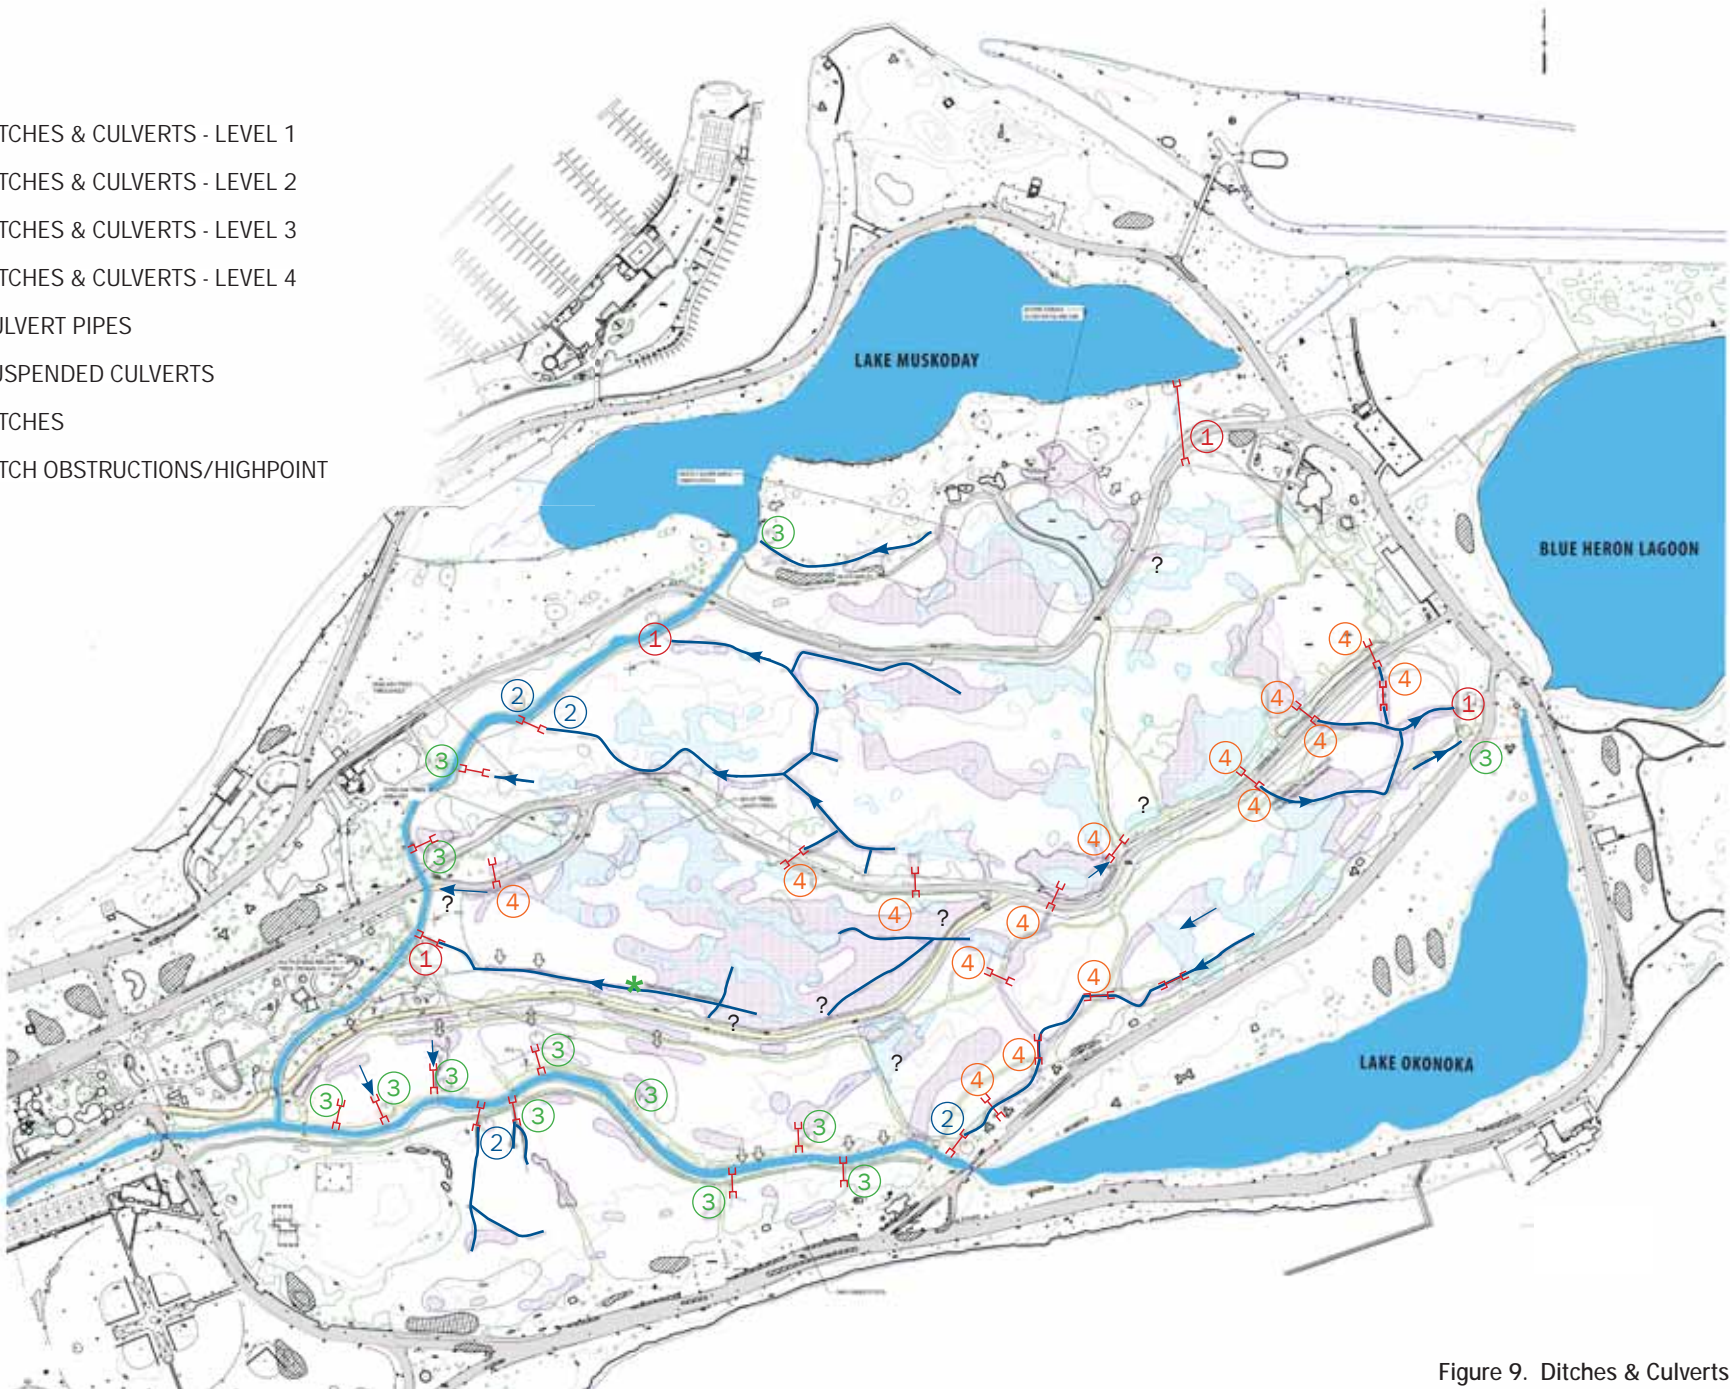
Figure 9. Ditches & Culverts

deepest and widest, have a well-developed network of lateral ditches and/or serves as the only outlet for that area. Three of the outlet culverts are located in some of the lowest topographic elevations within the flatwoods and somewhat follow the historic drainage patterns. The fourth ditch adjacent to Safari Zoo actually reverses the direction of the historic flow and discharges into Sylvan Canal. The impacts on pool development within the influences of the ditching is clear. Pool development is almost non-existent except within the actual banks of the ditches and ponding water is only evident during spring runoff. The level 1 underground storm sewer system draining the flatwoods to Lake Okonoka will be removed as part of the work associated with the habitat enhancements and will be converted to overland flow.

The remainder of the level 4 pipes are associated with historic bridle trails and are now abandoned and overgrown with mostly honeysuckle or fallen ash trees. In these locations, small diameter pipes were either placed on top of existing grade and fill placed above, or they were partially embedded into the soil with ditching similar to what was observed along Central Avenue. In several instances, either the trail has been washed out rendering the pipes non-functional, or the pipes are mostly plugged with soil causing larger pools to form that would otherwise be dry.

- Remove all culvert pipes and fill all ditches to match adjacent grades. Where soil is windrowed from original excavations, use this soil as backfill. Under certain conditions, ditches may have to remain as part of preserving the canals but will require control structure(s) to regulate the pools being effected by said ditches.

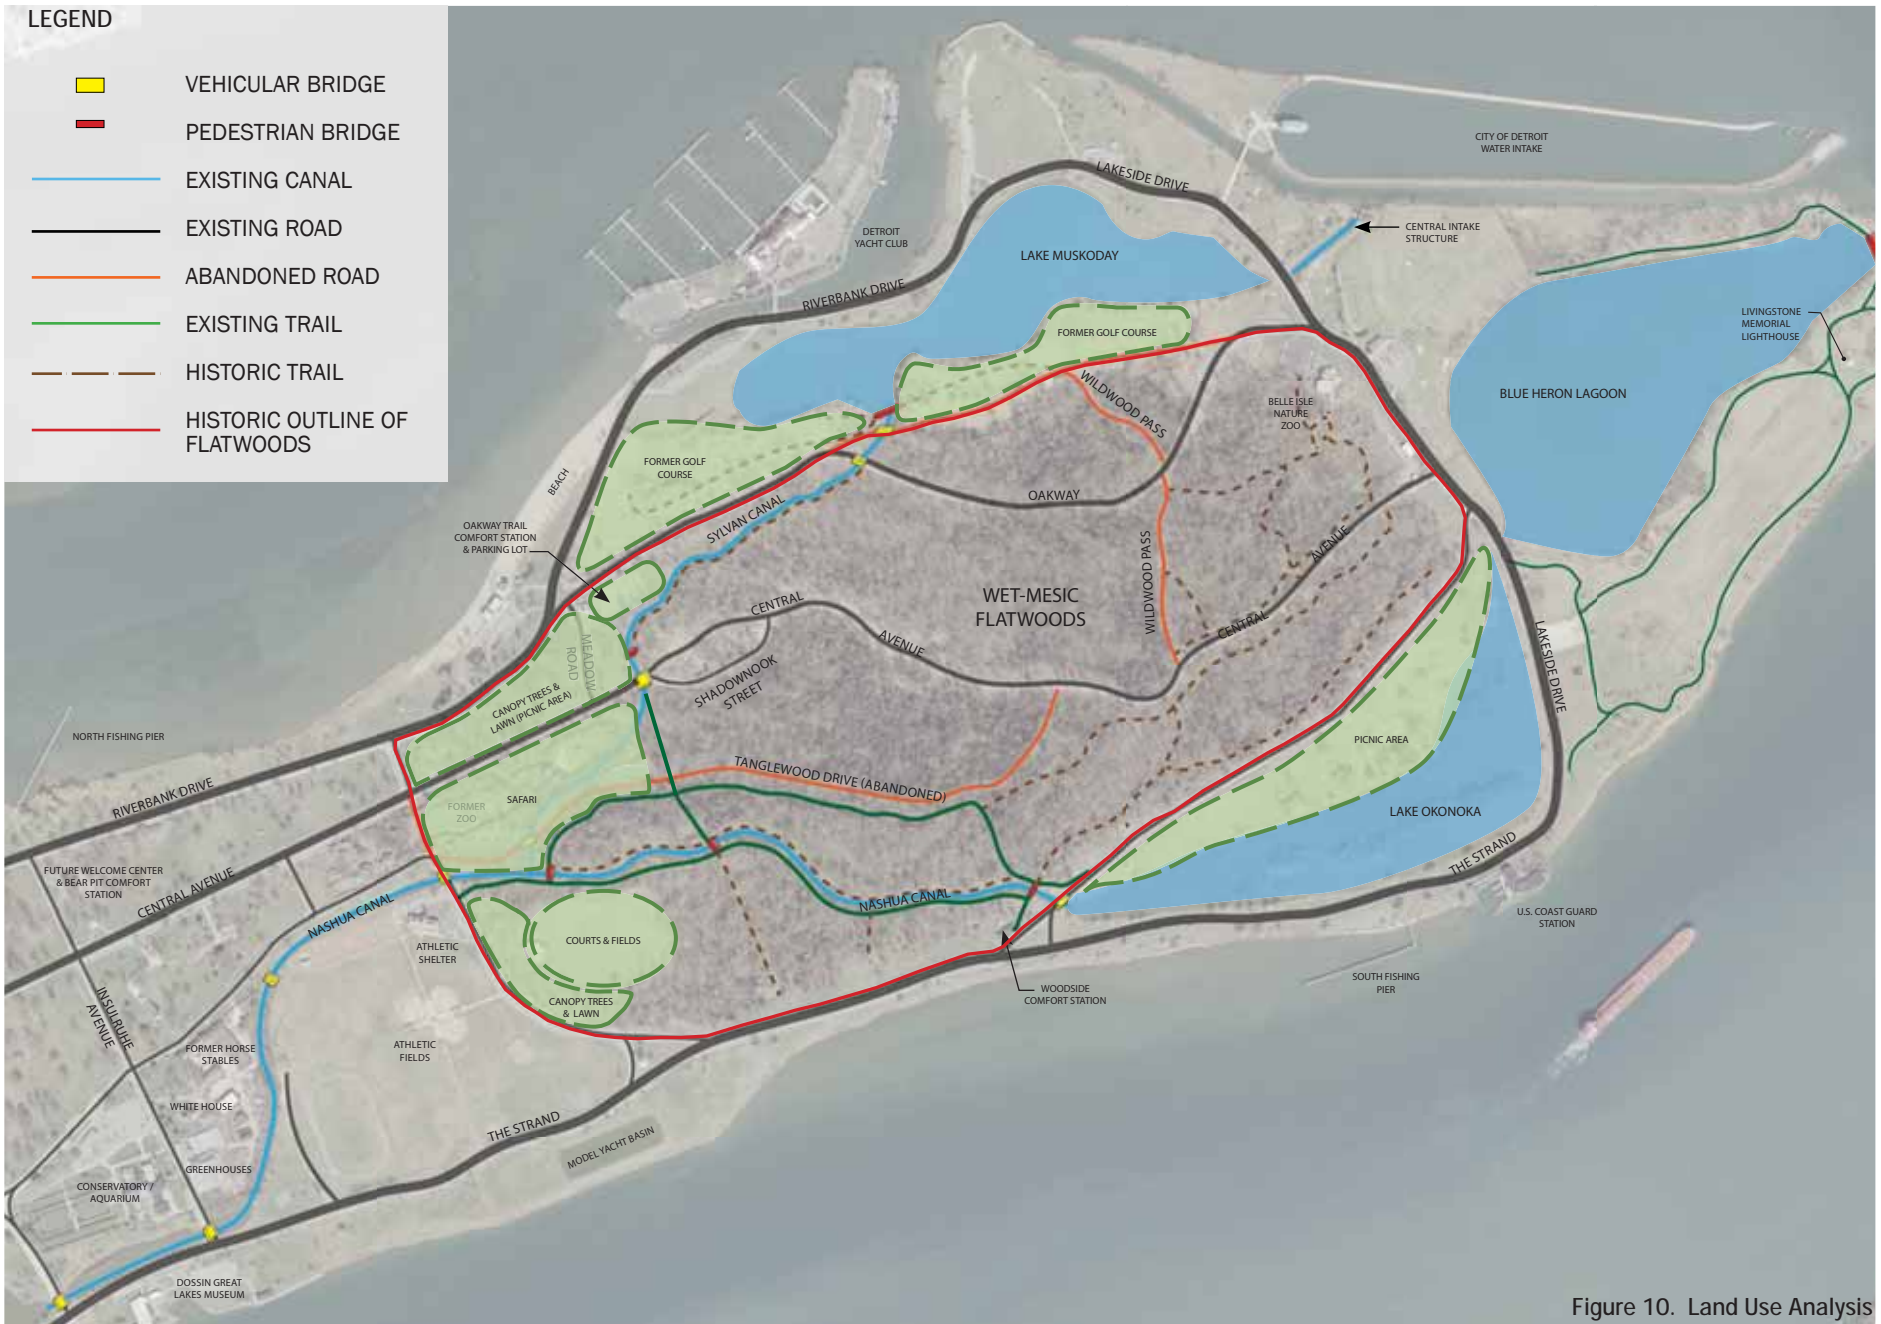
Figure 10. Land Use Analysis

- **Former Safari Zoo and Related Structures.** Sylvan Canal divides the Safari Zoo into two sections with the majority of the facilities located on the west side. On the west side, fencing, buildings, landform and non-flatwoods vegetation dominate the site. Water recreation via Sylvan Canal is barricaded with fencing. In this location, the flatwoods vegetation and topography has been significantly altered and is not a high candidate for restoration. The Safari Zoo footprint in this location is located along one of the highest natural elevations on Belle Isle and has minimal impacts on the current flatwoods hydrology. On the east side, fencing and changed topography is present and would be a candidate for restoration.

- **Athletic Courts and Field.** This use contains a concrete handball court, asphalt basketball court and a +/- 7 acre field that is occasionally used for open field recreation. The fill in this location is extensive and exceeds 7 feet in the center. The fill extends nearly to Nashua Canal, creating a linear remnant flatwoods band that contains several large flatwoods trees and good seasonal

ponding. Along the east side of the field extending into the natural areas, the flatwoods is partially degraded and may contain low amounts of fill (less than 1 foot). The tree lined perimeter along Vista Avenue contains several large flatwoods trees and original topography with many wet spots in the spring, but the understory has been replaced with turf. Restoration opportunities exist around the entire perimeter and along Nashua Canal.

- **Woodside Comfort Station.** This structure has no current impacts on the flatwoods except that it appears that minor ditching has occurred to the north to reduce ponding in the low areas around the structure. The walkway to the flatwoods and footbridge over the canal will be replaced as part of the Lake Okonoka Habitat Restoration project.
- **Picnic Area.** Much like the former golf course, this use occupies part of the historic drainage patterns for the south half of the flatwoods and was part of the historic wetland complex. Most of the original topography has been altered and fill for picnic shelters and Woodside Drive effectively block the historic surface drainage. Between Woodside Drive and the flatwoods, several abandoned picnic structures and slabs

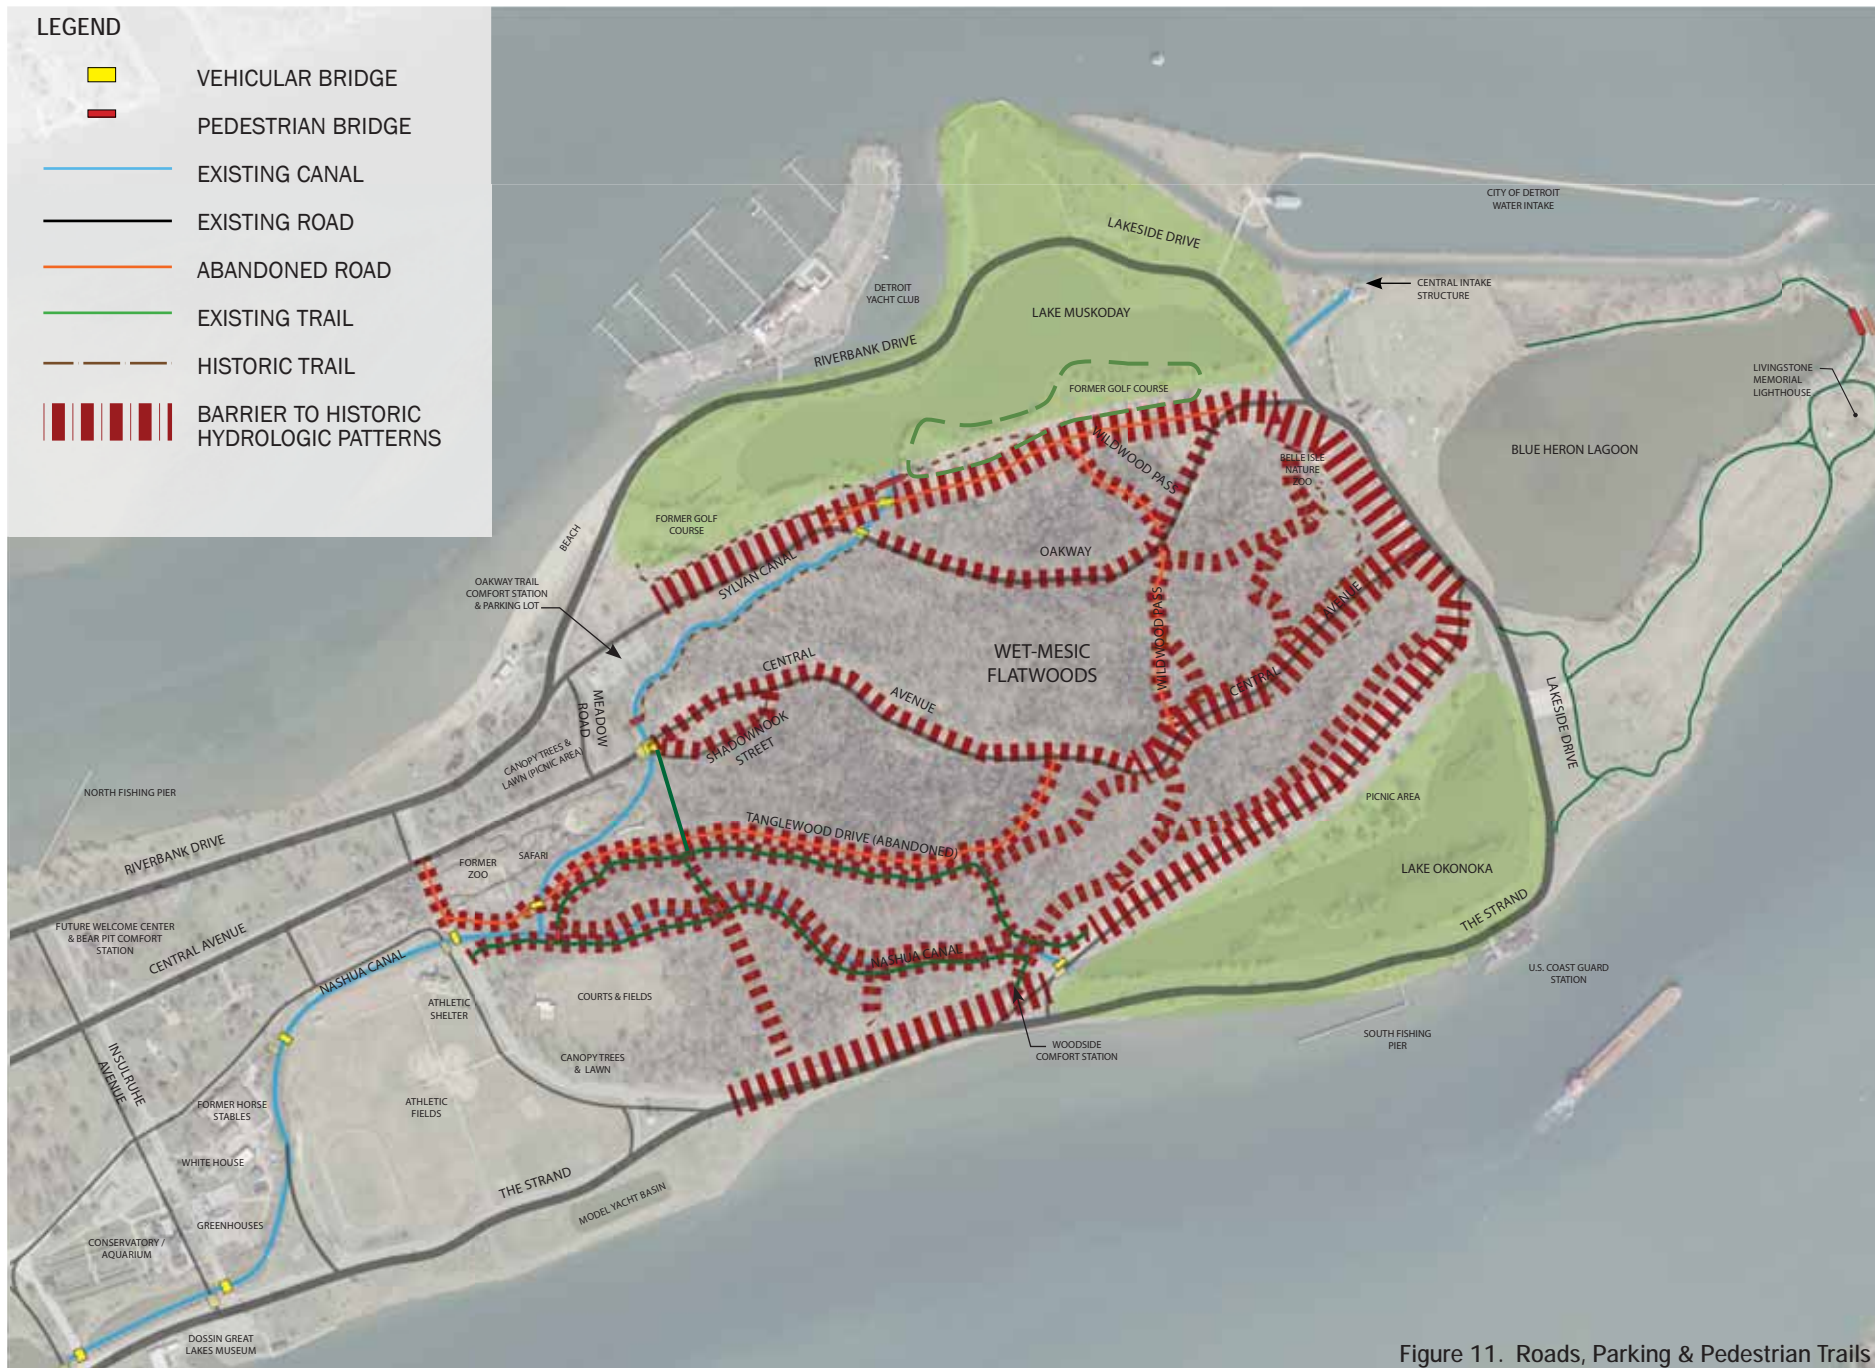
Figure 11. Roads, Parking & Pedestrian Trails

The internal asphalt road system (Woodside Drive, Central Avenue, Shadownook Street, abandoned Tanglewood Drive, Wildwood Pass, Oakway Trail and Meadow Road) fragment the flatwoods into cells that block historic drainage patterns and create upland shoulders that have become established with predominantly non-native upland plant species. Wildwood Pass on the north side of Oakway is gated and used by maintenance staff, while the south half has been converted to an active trail. Most of the roads have been constructed on less than 2 feet of fill and during the spring when pool development is greatest, standing water can be observed in several locations on opposite sides of the road providing indications of historic drainage patterns. The numerous, level 4 ditches and equalizer pipes were installed in many of these locations to address drainage but are now mostly non-functional adding to the concerns about pool hydrology and its effects on tree vitality.

- **Trails.** The trail system through the flatwoods is extensive and creates similar impacts to the flatwoods hydrology as the internal roads. Trails are categorized as active (asphalt) and abandoned and all were part of the historic trail system constructed for horseback riding and hiking. Most of the trails were constructed on less than 1 foot of fill, and in the spring when pool development is greatest, standing water can be observed in many locations along the active trails as surface flows attempt to make their way to the Nashua Canal. The abandoned bridle trails are difficult to locate and navigate due to the abundance of honeysuckle that has become established in the fill. Like the roads, these trails have numerous level 3 and level 4 ditches and drainage pipes in an effort to keep the trails dry.

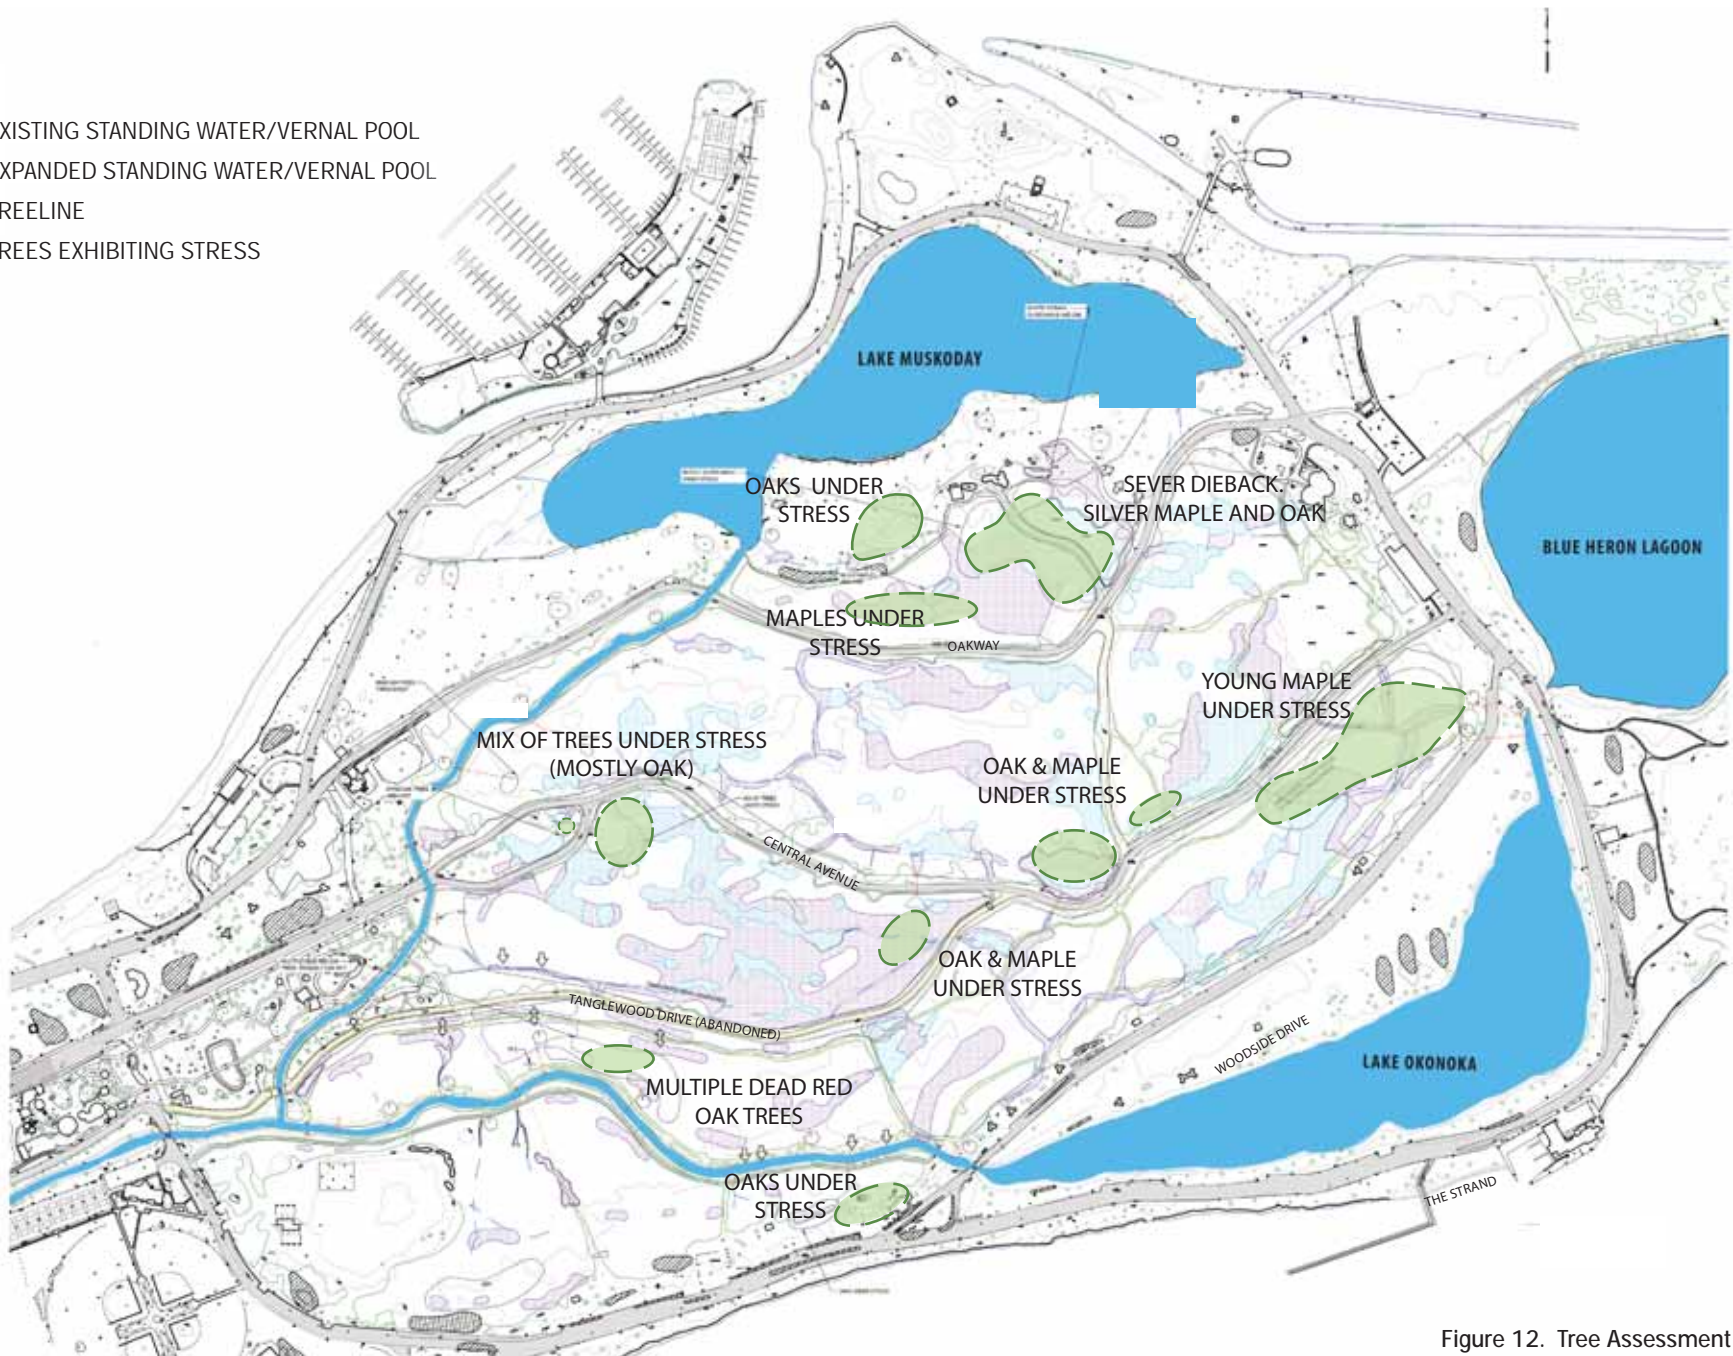
Figure 12. Tree Assessment

- During the growing season, canopy conditions were visually evaluated for health and vigor, and it became clear that a number of oak species and some maple species are under varying stages of decline or dead. This was mostly attributed to the presence of prolonged standing water (Figure 12). These locations are described in greater detail in the *Flatwoods Enlargement Analysis* section.
- In late-summer, at the onset of plant dormancy, most of the trees shown in Figure 12 are identified as being under stress and were experiencing early dormancy (approximately 2 weeks ahead of the healthier stand of trees, even though many of these areas no

While the summary of observations under this system analysis concludes that tree vitality is linked to pool hydrology, to what degree is uncertain. Other topics that would provide added benefits to better understanding this relationship and the other terrestrial and aquatic systems of the flatwoods not part of the current scope include:

- Establish a tree planting program using Belle Isle genotypes to replace lost ash trees where existing trees are not recolonizing. Ideally, more oak species would be introduced since silver maples are the dominant species and are generally performing well.

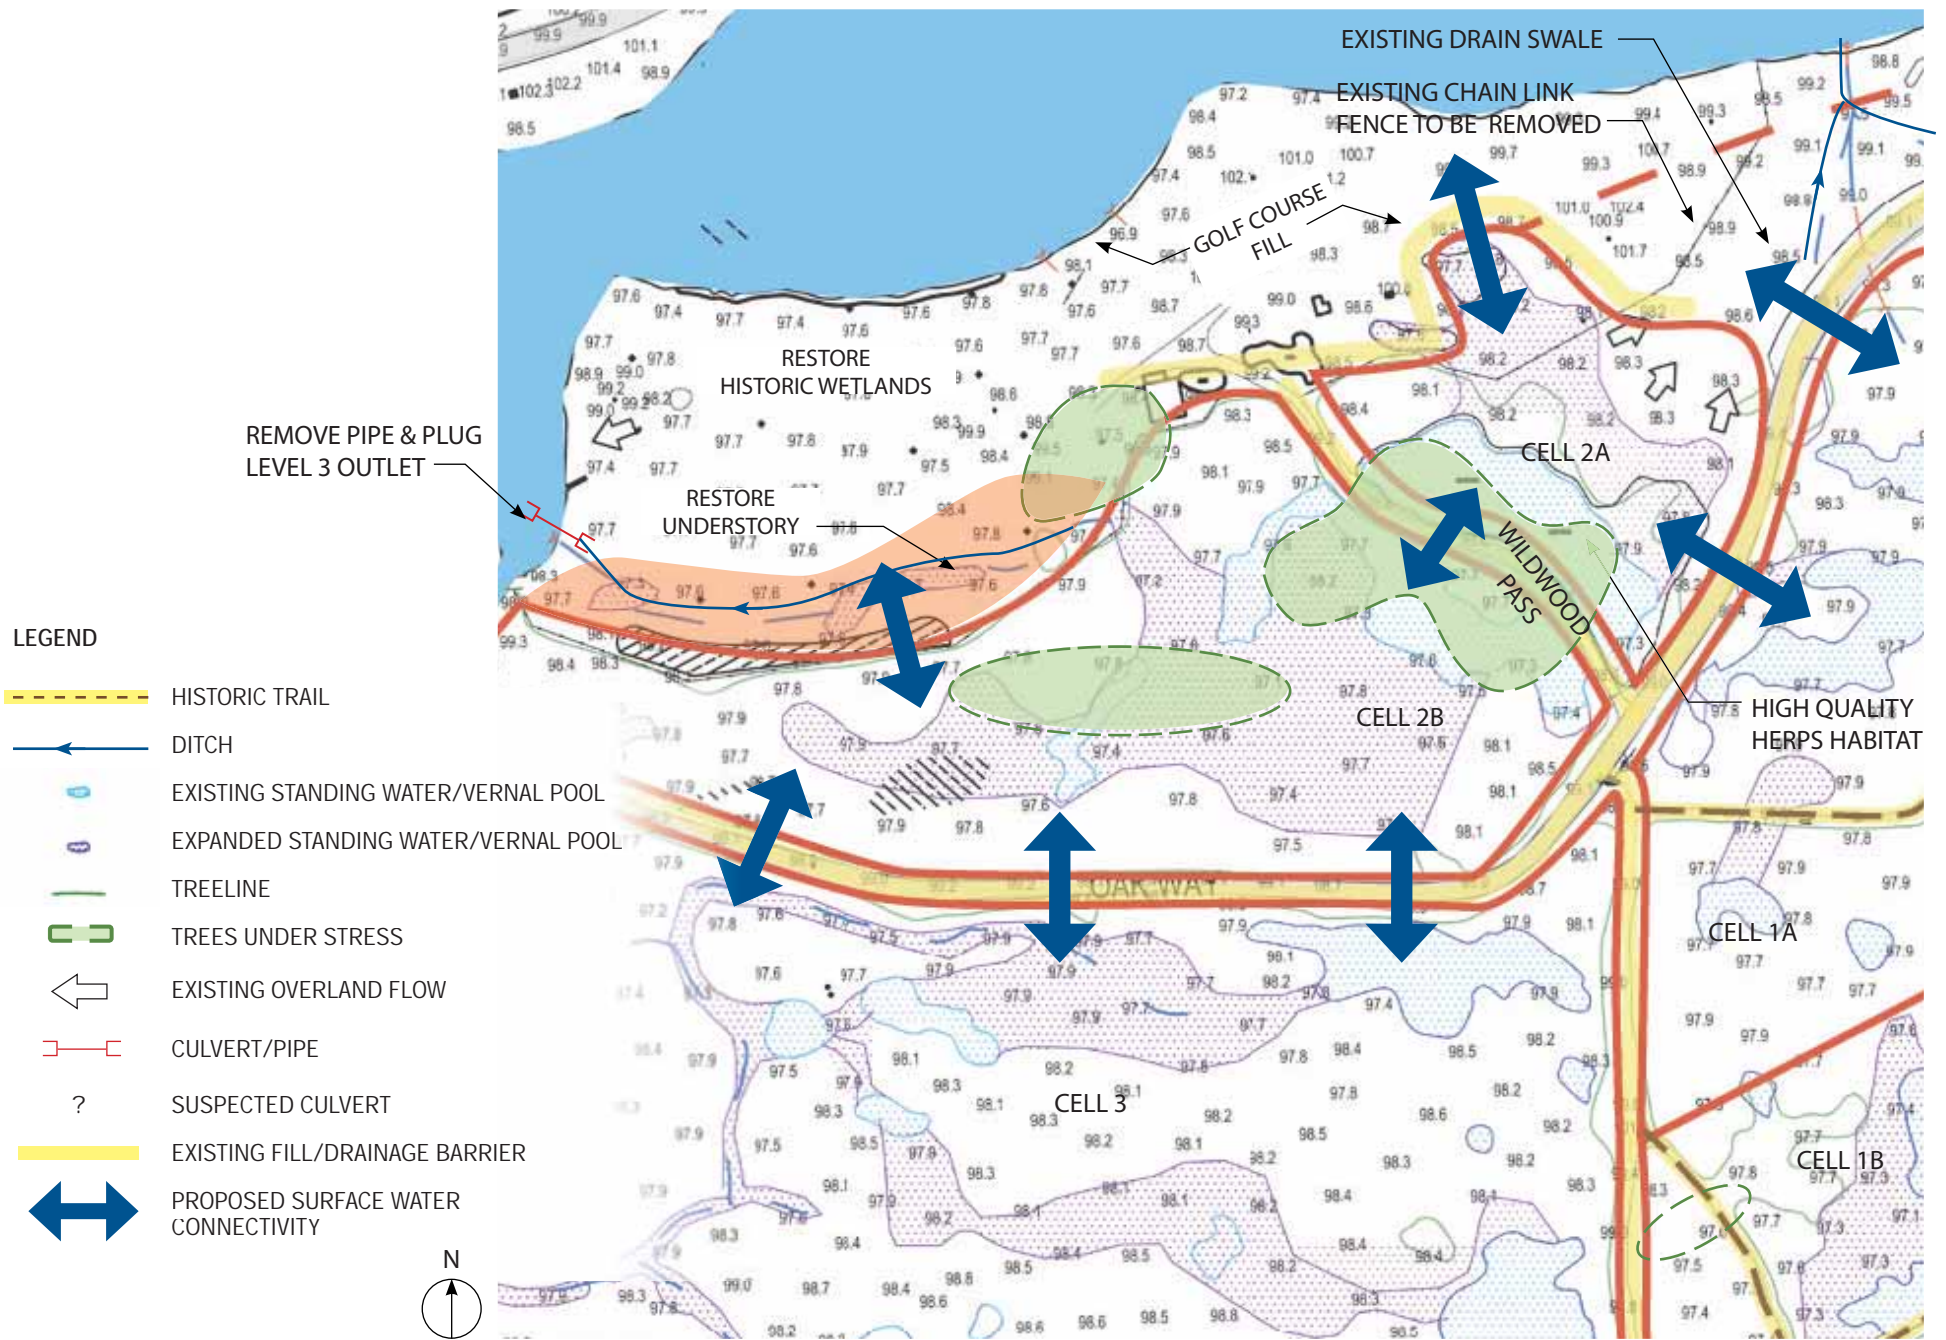
Figure 15. Flatwoods Division - Cells 2A & 2B

Cell 2A is +/-3 acres and contains mostly standing water that historically drained toward Lake Muskoday. It was also historically connected to Cell 1A and 2B, but no level 4 culverts were observed under Oakway or Wildwood Pass. Wildwood Pass and the golf course fill currently create drainage barriers, and there is no clearly defined outlet such as a

drainage ditch or culvert pipe. During extreme high water periods, surface water drains to the east and overflows across mowed lawn before discharging to Lake Muskoday. The original open water pool is the deepest pool in the flatwoods, contains an abundance of herpetofauna and serves as an important habitat. All of the trees within this pool have died, some are still standing and provide excellent habitat for cavity dwelling bird species. This condition has existed for a considerable length of time and is considered a stable system supporting excellent herpetofauna habitat.

Conversely, the eastern half of this cell also contains prolonged inundation and has caused significant dieback to the remaining large diameter oak species. This is one of the pools that seems to be growing in size and could be attributed to fallen ash trees (but is uncertain) or possible plugged level 4 pipes that were not encountered. These dying trees can be clearly seen from Oakway Trail and are most likely beyond the point of recovery even if the excess water is removed. Dense colonies of several juvenile tree species are becoming established in this location indicating that if this excess water is removed, the flatwoods canopy trees will become reestablished.

Cell 2B is +/- 11 acres and contains a large pool adjacent to the Wildwood Pass across from the Cell 2A pool. No physical connection was observed and water in Cell 2B is slightly lower in elevation than 2A. In the spring, this pool

enlarges to the west and occupies a substantial portion of the cell's interior that eventually is reduced to a small perennial pool adjacent to Wildwood Pass. The entire cell discharges from a single location directly behind the abandoned golf course building. Due to golf course fill between this discharge and Lake Muskoday, water draining from the cell interior sheet flows westerly just outside the chain link fence (no clearly defined ditch) and eventually discharges into Sylvan Canal at its confluence with Lake Muskoday via a small drain tile and overland flow. It is unclear how far into the golf course the drain pipe extends, but it appears to be no more than 50 feet to 75 feet long. Where the cell surface water discharges into the golf course, the large oak trees are starting to show signs of stress. Adjacent to this point, a small cattail pond exists and is discharging additional water (broken water main) into the swale. The excess water within the interior of the cell and tree decline (chlorine) could be the reason for the current condition.

Within the cell, no surface water discharge to the canal was observed and existing grades are over 1 foot higher than the remainder of this cell, suggesting dredge spoils were placed along the bank. It is difficult to determine the connectivity between Cells 2B and 3 due to the level 1 ditch that parallels Oakway Trail in Cell 3.

- Repair the broken water main or abandon in place.
- Consider the restoration of the golf course to wet meadow wetlands between the drainage swale and Lake Muskoday by dispersing the cell discharge water (includes shallow excavations).

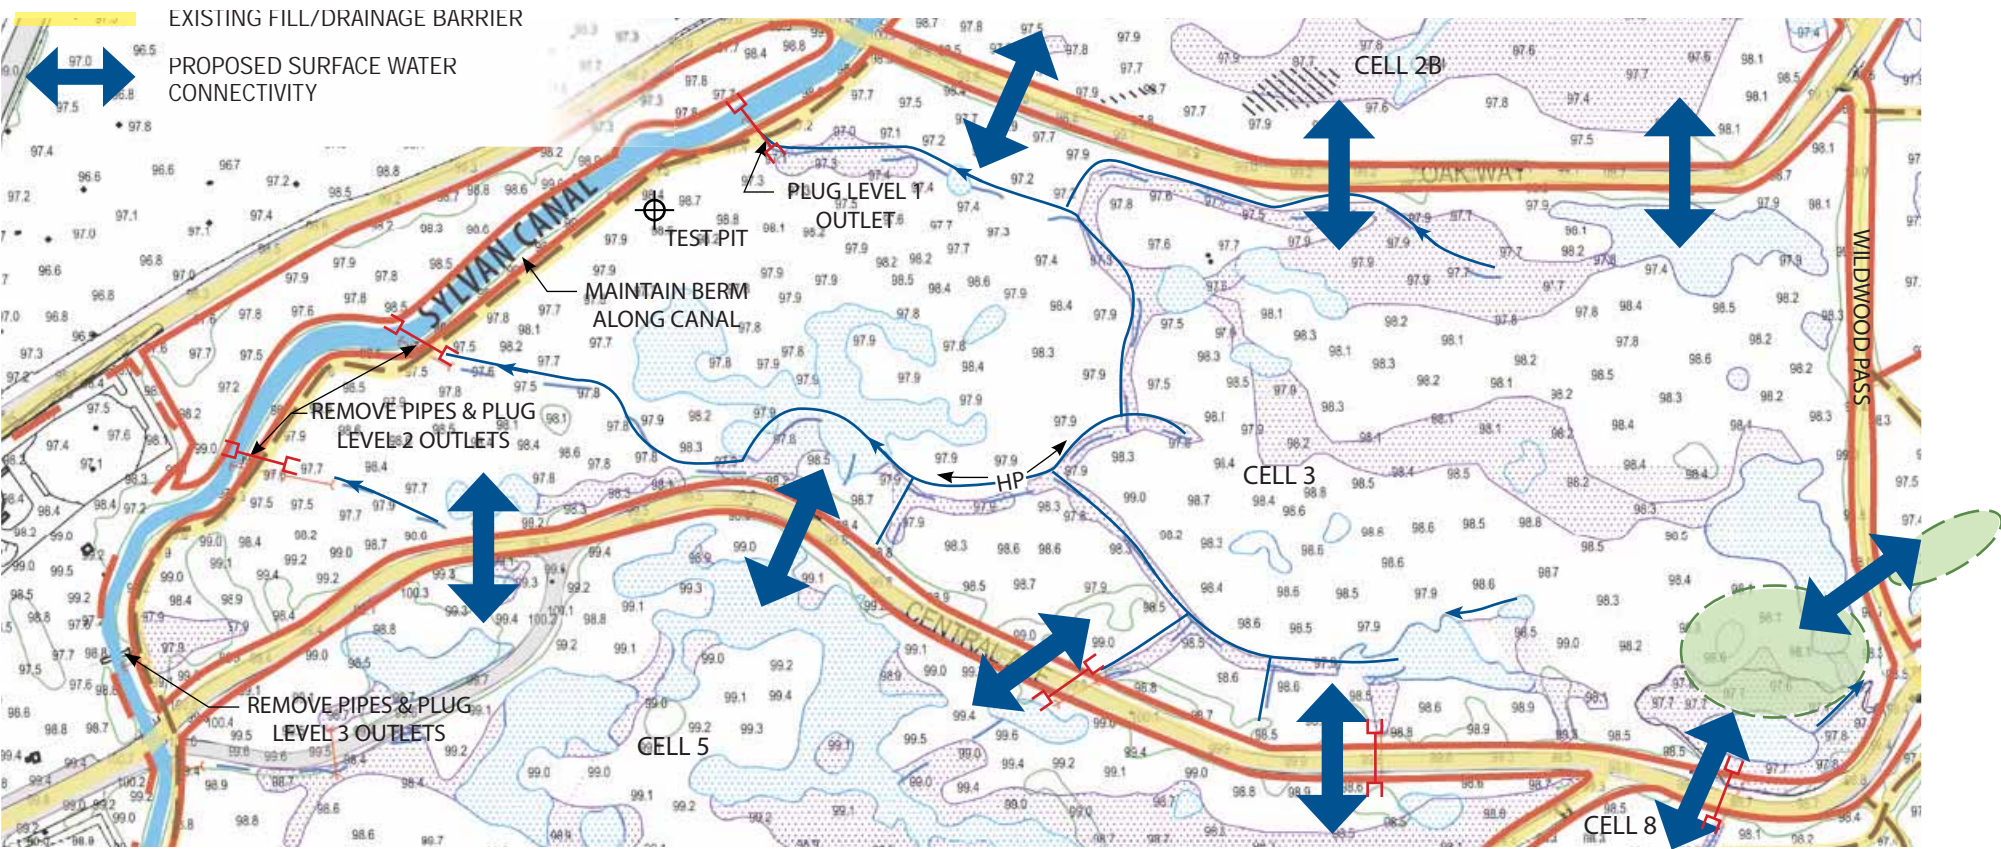
Figure 16. Flatwoods Division - Cells 3

Defined by Oakway Trail, Sylvan Canal, Central Avenue and Wildwood Pass, Cell 3 encompasses +/- 39 acres including Sylvan Canal (Figure 16). From a hydrologic perspective, the western half is heavily degraded due to ditching. The ditching is extensive and impacts over 50% of the cell. Historically, Cell 3 drained north and northwest across Oakway Trail and the Sylvan Canal through Cell 2B to the wetland complex now occupied by Lake Muskoday and the abandoned golf course. Today, the entire cell drains into Sylvan Canal. The three drainage ditches (level 1 and level 2) were strategically constructed through the lowest elevations of the cell before discharging into the Sylvan Canal. The impacts on pool development from these ditches are evident. Within this zone of influence, pools are small and linear and mostly associated with the ditches or are seasonal (spring runoff). The level 1 drainage outlet and ditch has the greatest impact on cell hydrology and extends furthest into the site. It is deep and wide near its outlet and meanders throughout the western half of the cell. The two level 2 and one level 3 ditches and outlets have localized impacts on cell hydrology. All four outlets contain small diameter cast iron pipes that allowed cell water to drain to the canal below the informal foot path that still exists today. At the level 1 outlet, the culvert is washed out, heavily eroded and a boardwalk section was installed to maintain trail access.

Ponding in the eastern half of the cell is well developed with three linear pools that eventually are drained by the primary ditch and through evaporation. By late summer, pools are dry except for a small area in the southeast corner next to Central Avenue. In at least three locations, equalizer pipes were observed across Central Avenue connecting to and draining Cells 5 and 8, which attempts to follow the natural flow patterns but are mostly blocked, and no flow was observed (see Cell 5 narrative).

Tree condition throughout the cell appears healthy except for a small cluster of maples in the southeast corner of the site that is attributed to ponding water. Like Cell 2B, the loss of ash trees is clearly noticeable especially along the western edge of the cell approaching Sylvan Canal where tree canopy is semi-closed to open, reed canarygrass (*Phalaris arundinacea*) is the predominantly understory vegetation, and no seasonal pools were observed. Amur honeysuckle (*Lonicera maackii*) is predominant in this location due to the absence of historic hydrology. No surface water discharges to the canal except at the ditch outlets, and existing grades are over 1 foot higher than the remainder of this cell suggesting dredge spoils were placed along the bank for trail use.

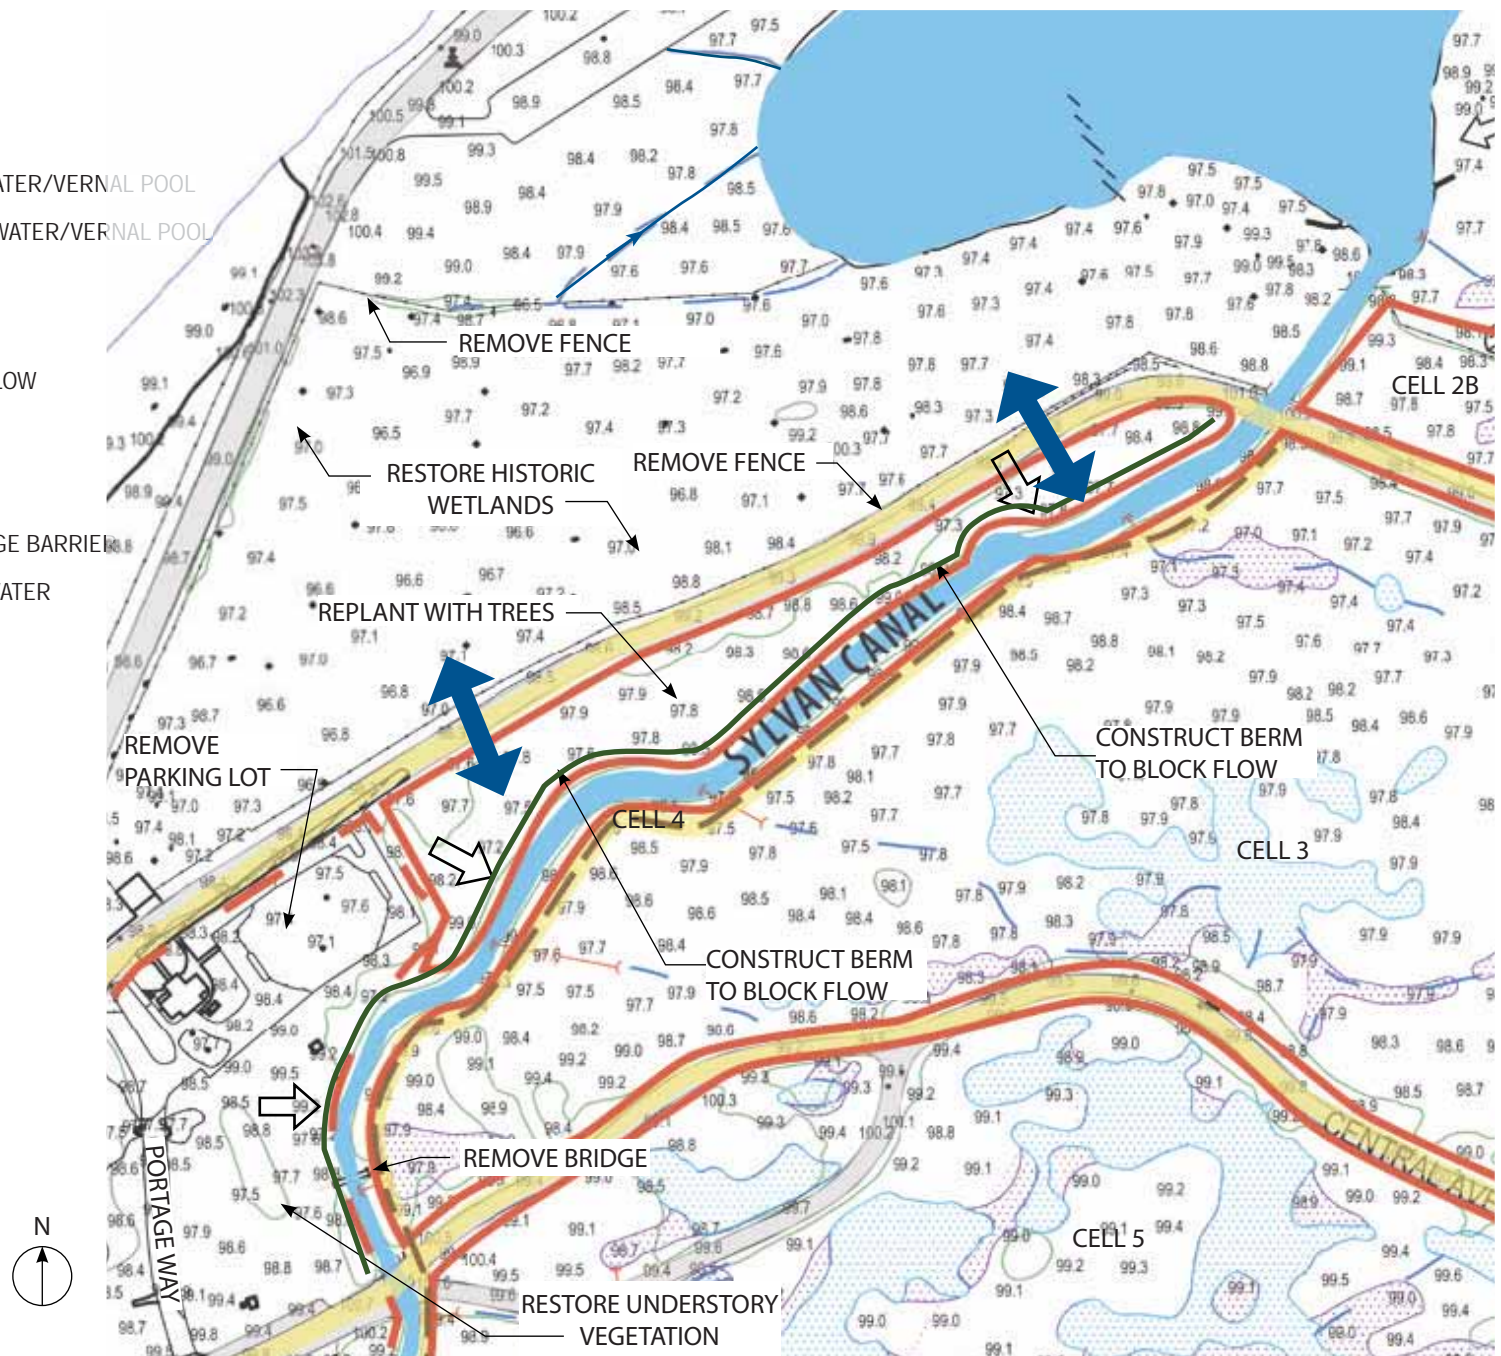
Figure 17. Flatwoods Division - Cell 4

Cell 4 has been heavily degraded and is considered low quality due to several factors.
