**2016 BELLE ISLE
COMPREHENSIVE
HYDROLOGIC
ASSESSMENT**

REPORT OBJECTIVES

In response to tasks 2A and 2B of the Lake Okonoka Habitat Restoration project, this report aims to gain an understanding of the current hydrology on Belle Isle specific to the +/- 200 acre natural area referred to as the wet-mesic flatwoods forest (flatwoods).

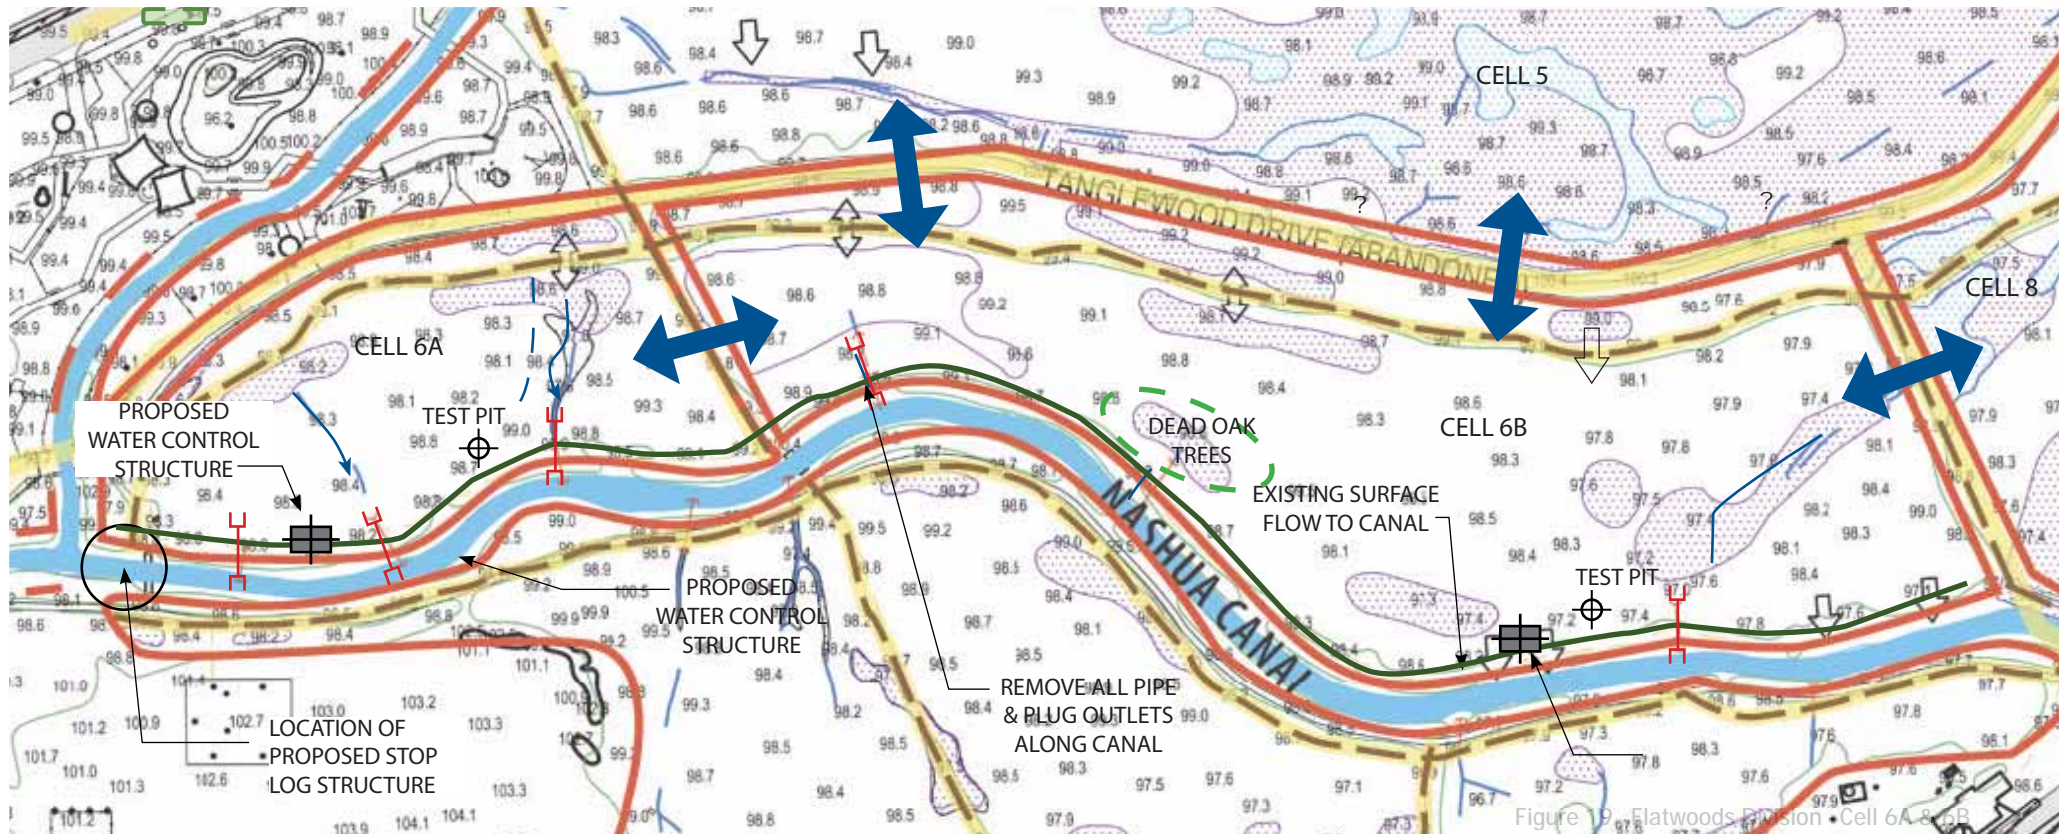
Figure 9. Flatwoods Division - Cell 6A & 6B

The asphalt path separating Cell 6B from 8 is a barrier that blocks the migration of surface water between pools. This same path that parallels Tanglewood Drive is wetter than 6A and several low, wet areas can be observed on the path throughout the spring.

One note of interest is that the resident beaver(s) occupy this portion of Nashua Canal, and gnawing on the riparian trees was observed.

- Consider restoration of this cell to extend to Vista Drive to follow its original boundary. This will require the removal of a large amount of fill, the basketball courts and the handball court. At a minimum, consider flatwoods understory restoration around the perimeter of this fill to historical west limits (Vista Drive).
- Remove surplus fill placed in flatwoods at northeast corner of mowed field and fill area.
- Between basketball court and Nashua Canal, widen natural areas as much as possible (+/- 100 feet) and install at least one water control structure to maintain linear pools.
