Lake Okonoka Habitat Restoration Herpetological Monitoring Report

June 2022

Herpetological Resource and Management, LLC P.O. Box 110 Chelsea, MI 48118 (313) 268-6189

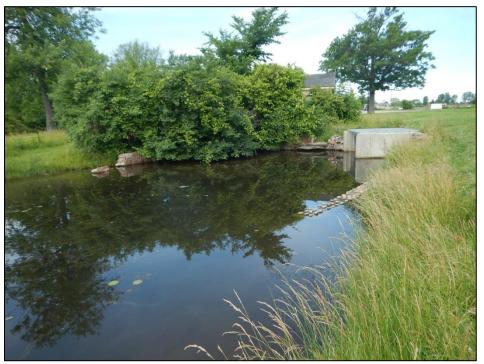
Photo 1. Pre-restoration photo of the old culvert connecting Lake Okonoka to Blue Heron Lagoon (HRM 2015).

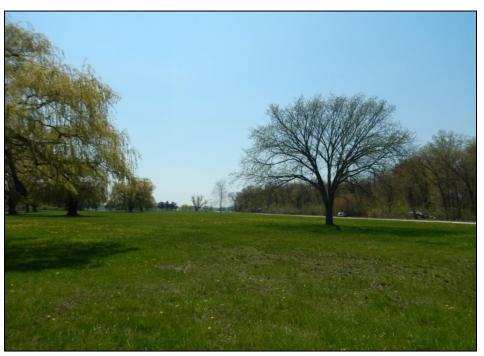
Photo 2. Pre-restoration photo from the northwest side of Lake Okonoka showing maintained lawn $(HRM\ 2015)$.

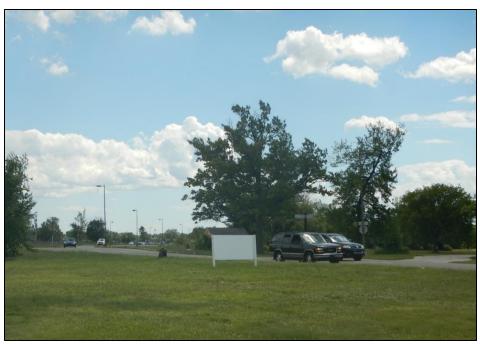
Photo 3. Pre-restoration photo of Lake Okonoka showing mowed grass and high traffic volumes (HRM 2015).

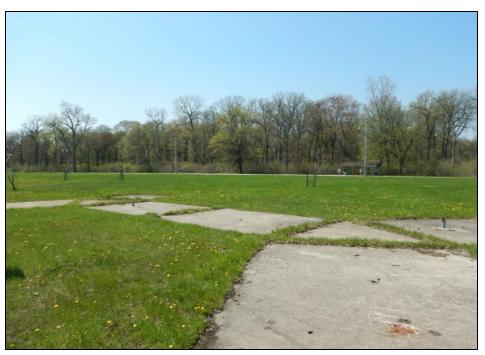
Photo 4. Pre-restoration photo of the west side of Lake Okonoka showing old concrete slabs and short lawn grass (HRM 2015).

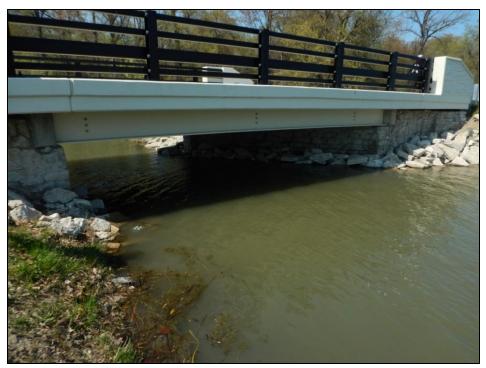
Photo 5. Pre-restoration photo showing the Nashua Canal Bridge with little riprap material and limited snake habitat (HRM 2015).

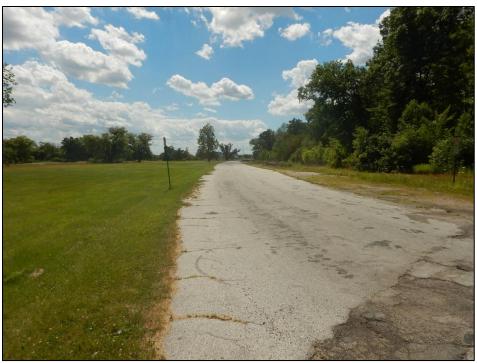
Photo 6. Pre-restoration photo showing a paved road (Woodside Drive) fragmenting habitat on the west side of Lake Okonoka (HRM 2015).

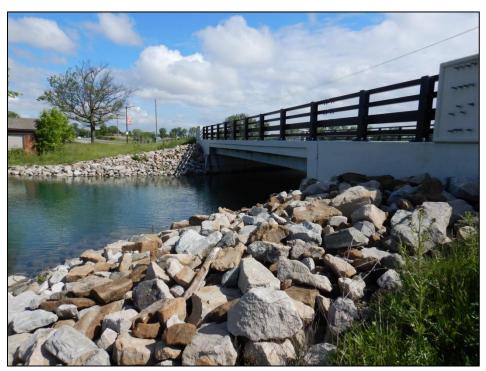
Photo 8. Riprap made up of large rocks on the sides of a culvert connecting Lake Okonoka to Blue Heron Lagoon. This area supported several Northern Water Snakes.

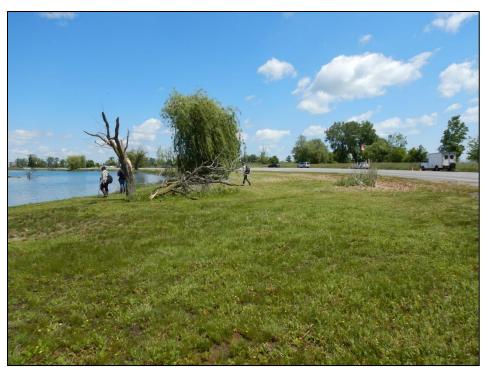
Photo 9. Mowed vegetation extending from the road to the water's edge on Lake Okonoka's west side. Fragmented patches of potential habitat scattered throughout (fallen tree on the left and small patch of cattails on the right).

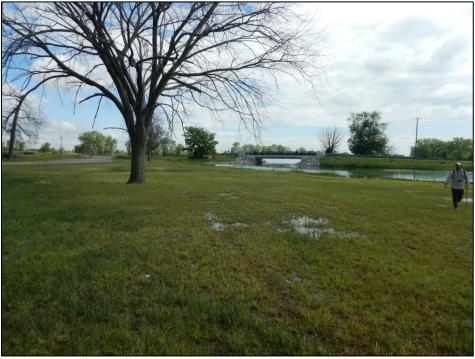
Photo 10. Mowed vegetation extending from old Woodside Drive (now lawn) to water's edge on Lake Okonoka's east side.

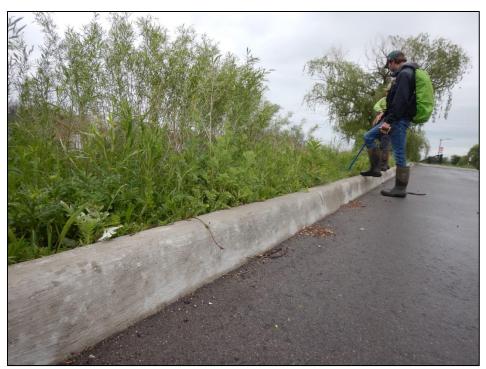
Photo 11. High curb along The Strand Road near the South Fishing Pier on the eastern side of Lake Okonoka.

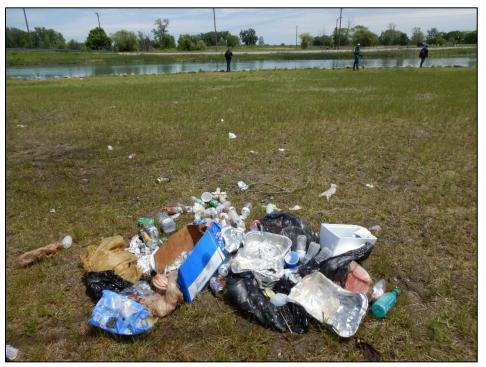
Portions of the shoreline of Lake Okonoka have a narrow swath of trees and shrubs with herbaceous vegetation present. The upland herbaceous vegetation was observed to have been recently mowed during our 2022 field assessments on all sides (north, south, east, and west) of Lake Okonoka (Photo 9 and Photo 10). A majority of the assessment area bordering The Strand Road on the east and north side of Lake Okonoka contain high vertical curbs, creating a barrier to herpetofauna movement (Photo 11). Significant litter from patrons was observed during HRM's habitat assessments including several instances of discarded fishing line along the lake's edge (Photo 12).

Photo 12. Trash observed during rapid habitat field assessment near Lake Okonoka.

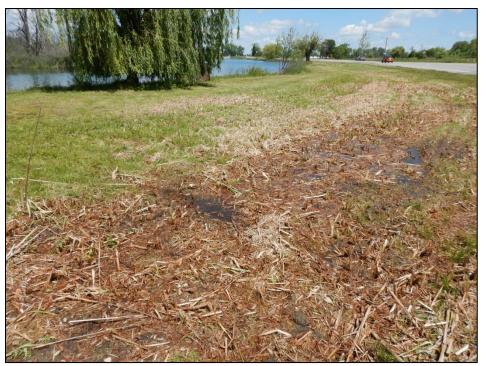
Photo 23. A wetland area that previously contained cattails, an important habitat structure for several species of herpetofauna, recently mowed near Lake Okonoka's edge.

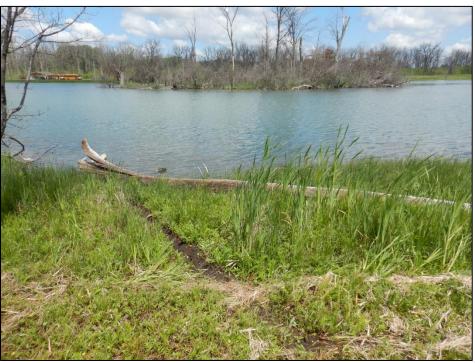
Photo 24. A fallen log, an important herpetofauna habitat structure, moved to allow for mowing near Lake Okonoka's edge.

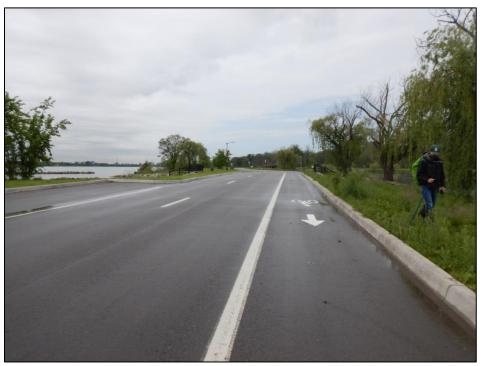
Removal/Alteration of High Curb: The 90 degree, high curb located along The Strand Road impedes herpetofauna movement, particularly for turtle species that cannot easily traverse the obstacle (Photo 26). Removal or replacement of this curbing with a low-slope option would reduce the number of wildlife-vehicle collision events as wildlife will not be trapped by these barriers (Figure 2). This will also allow for more mobility of species which can greatly increase their reproductive success.

Photo 26. High curb observed along The Strand Road creating a barrier to herpetofauna movement.

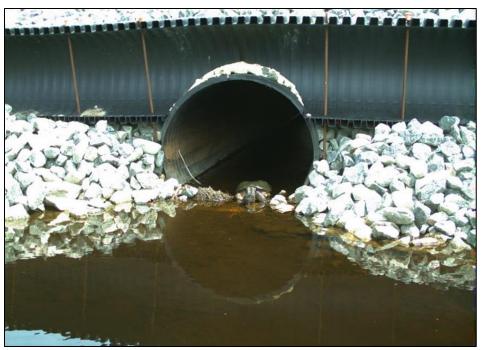
Photo 27. Culvert example showing an Eastern Snapping Turtle using a culvert to avoid a busy road. Photo credit: "Turtle Road Mortality Mitigation Project Final Report" by Glenside Ecological Serviced Limited, Project 14006.

connect herpetofauna habitat and reduce road mortality (Photo 27 and Photo 28). Culverts can be constructed from High Density Polyethylene (HDPE), Structural Steel Plate (SSP), Corrugated Steel Pipe (CSP), or concrete. It should be noted metal is a less desirable material due to its conductivity, making the passage cold during spring migratory periods. It is important for the diameter to be wide enough so that light can penetrate through the length of the tunnel (Photo 2). For example, for tunnels < 50 ft, diameter should be 5 ft; for tunnels 50-82 ft a diameter of 6 ft should be used (Ontario Ministry of Natural Resources and Forestry, 2016). If well placed, this corridor could significantly reduce the frequency of road mortalities (Photo 29).

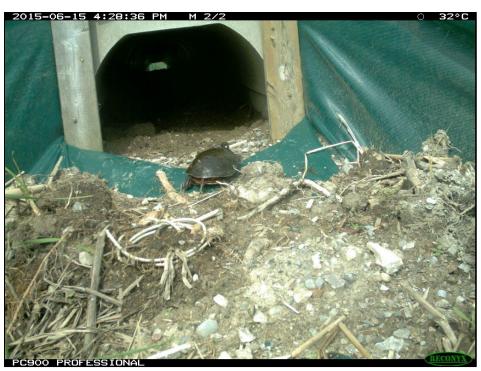
Photo 28. An example of a culvert in use: a Painted Turtle using a under-road culvert. Photo credit: "More aquatic wildlife culverts for Long Point Causeway" by LPCIP News, 2015.

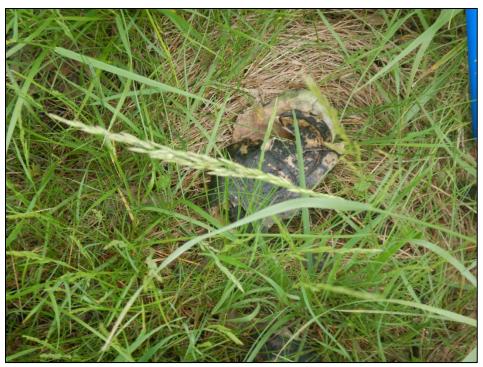
Photo 29. Shell of a deceased Northern Map Turtle found near The Strand Road, a likely road mortality.

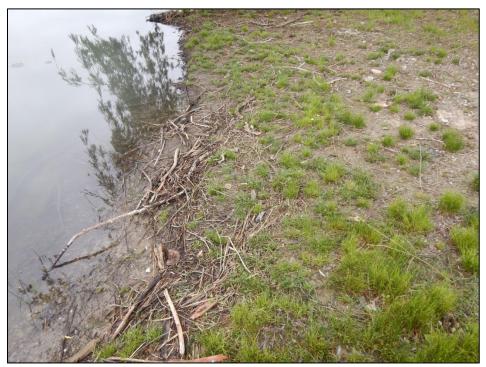
Photo 30. Mowed grass bordering Lake Okonoka's edge.

Restriction of Mowing and Mowed Locations: Mowing to the lake's edge was observed during surveys in select areas on all sides (north, south, east, and west) of Lake Okonoka, mowing was particularly damaging along Lake Okonoka's east edge (Photo 30). Lakeside edge vegetation provides critical habitat for herpetofauna species and should be avoided during mowing. Cattail wetlands were also observed to have been mowed, and natural cover objects had been moved to allow for mowing, both of these habitat features are critical to herpetofauna and loss can greatly inhibit restoration success (Photo 31). The transitional zone between upland and water provides basking opportunities and cover for frog, turtle, and snake species (Photo 32). A buffer of no less than twenty-five (25) foot from the water's edge around the entirety of Lake Okonoka should be left un-mowed to provide this crucial habitat. In recreational areas that are mowed several measures can be taken to reduce the impact of mowing on herpetofauna communities including mowing less frequently and adjusting mower decks higher (>6") in areas known to have herpetofauna. Alternatively, if

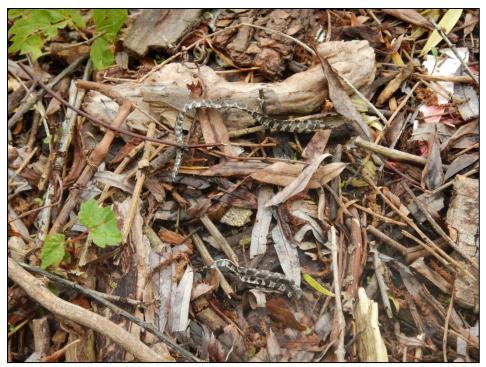
Photo 31. Remains of a deceased juvenile Northern Water Snake found on Lake Okonoka's east side, likely died due to mowing activity.

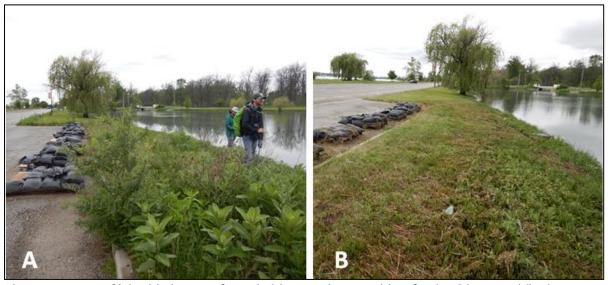
Photo 32. Loss of lakeside herpetofauna habitat on the east side of Lake Okanona. The image on the left (A) shows this location before it was mowed containing high vegetation, suitable for herpetofauna habitat with cover from the elements and protection from predation. The image on the right (B) shows this same location after it was mowed containing very low vegetation offering no habitat for herpetofauna or other wildlife.

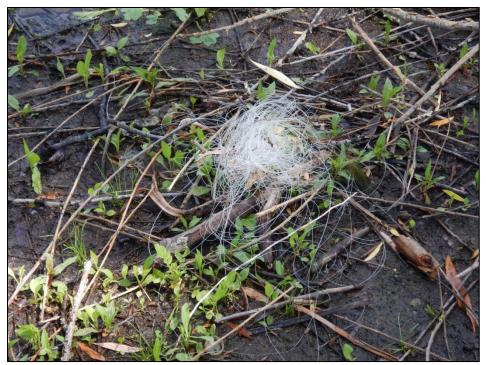
Photo 33. Discarded ball of fishing line observed near edge of Lake Okonoka.

Additional Garbage Receptacles: During surveys, large amounts of litter, including discarded fishing line were found along Lake Okonoka's edge (Photo 33). Installation of additional trash cans can help to discourage litter. Receptacles specifically designed for the disposal of fishing line should also be installed as discarded fishing line poses a threat to herpetofauna as well as other wildlife species.

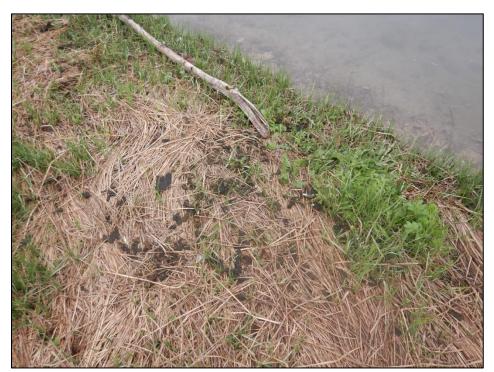
Photo 34. Large amounts of goose feces located near Lake Okanonka's edge. Large amounts of feces can cause nutrient loading into a water system and can lead to algal blooms and wildlife die-offs.

Excessive Nutrients: A high amount of geese were observed with many areas covered in goose droppings (Photo 34). These droppings release excessive nutrients (nitrogen and phosphorus) into the water and can lead to harmful algal blooms and wildlife die-offs (Mifsud 2014). Excessive nutrients in waterbodies can also lead to deformities and can have lethal effects in amphibians (Mifsud 2014).

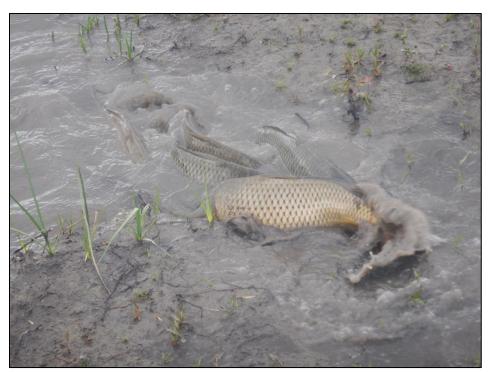
Photo 35. Common Carp observed in shallow water on the edge of Lake Okonoka.

Predator Management: Discourage the feeding of raccoons and other mesopredators and implement measures to make sure food refuse is removed from garbage receptacles in a timely manner. High amounts of Common Carp were observed near the shores of Lake Okonoka (Photo 35). Common Carp can act as a predator to baby turtles and amphibian larvae (Kloskowski 2009; Mifsud 2014). There are several methods for deterring or eliminating Common Carp from a pond including using fences, sound, or harvest.

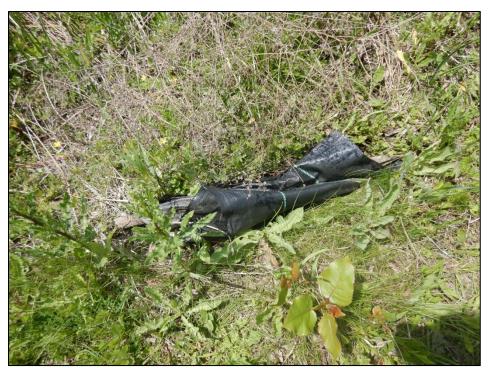
Photo 37. Soil erosion fencing still in place in the Lake Okonoka restoration area.

Removal of Silt Fencing: Remnants of silt fencing were observed on the north side of Lake Okonoka near the BHL culvert (Photo 37). Silt fence can create a barrier for herpetofauna and reduce connectivity, or can trap herpetofauna and result in injury or mortality. Silt fencing should be removed following restoration.

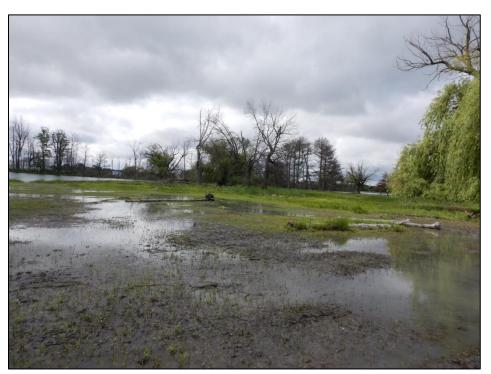
Photo 38. Muddy pools following a rain event on Lake Okonoka's west side.

Floodplain/Seasonal Wetland Restoration: Following recent rain events, it was observed that large areas of mowed grasses became muddy, barren floodplains with scattered pools of water (Photo 38). Introduction of floodplain vegetation would be very beneficial to these locations, stabilizing the soil, aiding hydrology, creating habitat, and making the area more ascetically appealing. Promoting the sustained presence of water on the landscape would increase local amphibian breeding habitat. Ceasing mowing activities and allowing the vegetation to grow would not only help in preserving these temporary wetlands but also provide habitat for recently metamorphosed frogs and toads.
