RE: Geotechnical Investigation Report
 Stony and Celeron Islands, Habitat Restoration
 Wayne County, Michigan

GEOTECHNICAL INVESTIGATION REPORT
DETROIT RIVER AREA OF CONCERN (AOC)
STONY AND CELERON ISLANDS
HABITAT RESTORATION
WAYNE COUNTY, MICHIGAN

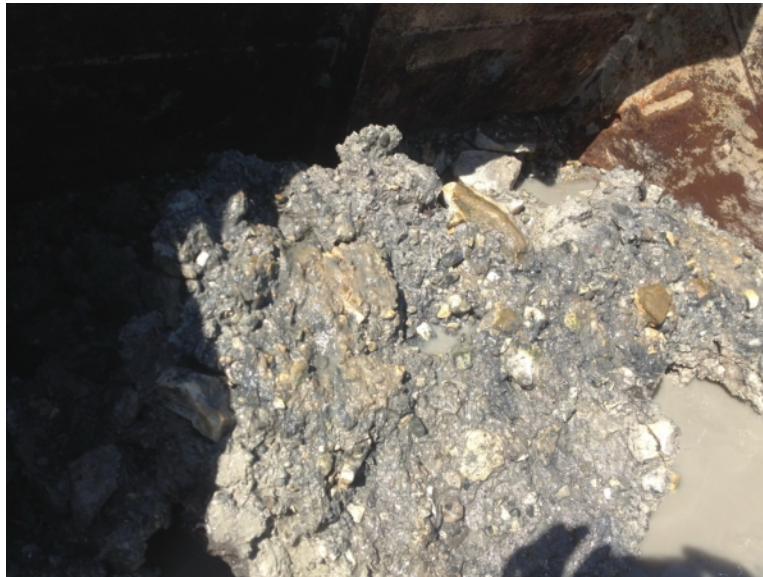
LOG OF SOIL PROFILE			FIELD DATA		LABORATORY DATA		
ELEVATION ft		Depth	DEPTH (ft)	SAMPLE NO.	SAMPLE TIP DEPTH (ft)	UNCONFINED COMP STRENGTH (psf)	MOISTURE CONTENT (%)
		Ground Surface Elevation 566 ft	0

SILTY MEDIUM TO COARSE SAND WITH COBBLES mixed with SILTY CLAY, trace to some sand, trace gravel, gray (SM/CL)		GB1	1.0		
				GB2	2.0		
				GB3	3.0		
563.00		Bottom of Test Pit at 3 ft. (Bucket refusal at 3 ft depth, possible top of bedrock)	3.0

TEST PIT COORDINATES
 E(x) Coordinate 13447988.0
 N(y) Coordinate 210729.0

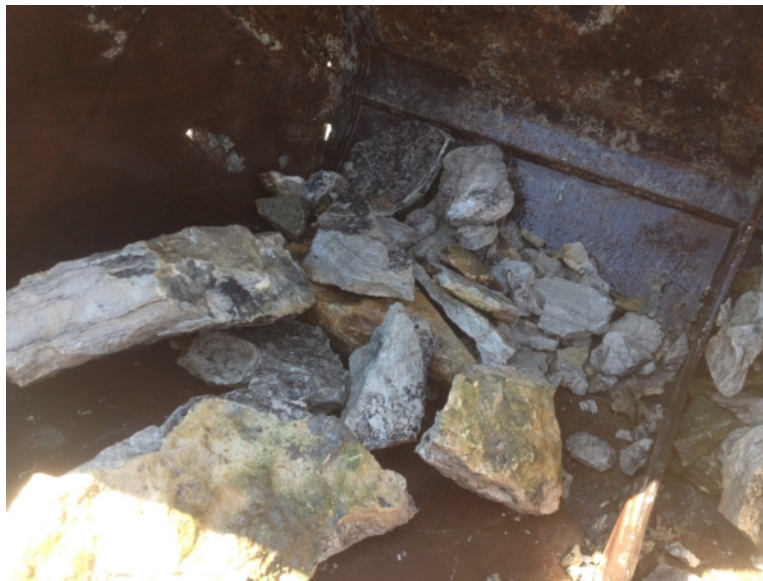
LOG OF SOIL PROFILE			FIELD DATA		LABORATORY DATA		
ELEVATION ft		Depth	DEPTH (ft)	SAMPLE NO.	SAMPLE TIP DEPTH (ft)	UNCONFINED COMP STRENGTH (psf)	MOISTURE CONTENT (%)
	Ground Surface Elevation 567 ft		0				
566.80

<p>Engineer reported BEDROCK COBBLES. Observed pieces of rock had thickness of 1 to 2 inches, with length greater than 12 inches.</p>	0.2					
	Bottom of Test Pit at 0.2 ft. (Bucket refusal at 0.2 ft depth, possible top of bedrock)

TEST PIT COORDINATES
 E(x) Coordinate 13448575.0
 N(y) Coordinate 210682.0

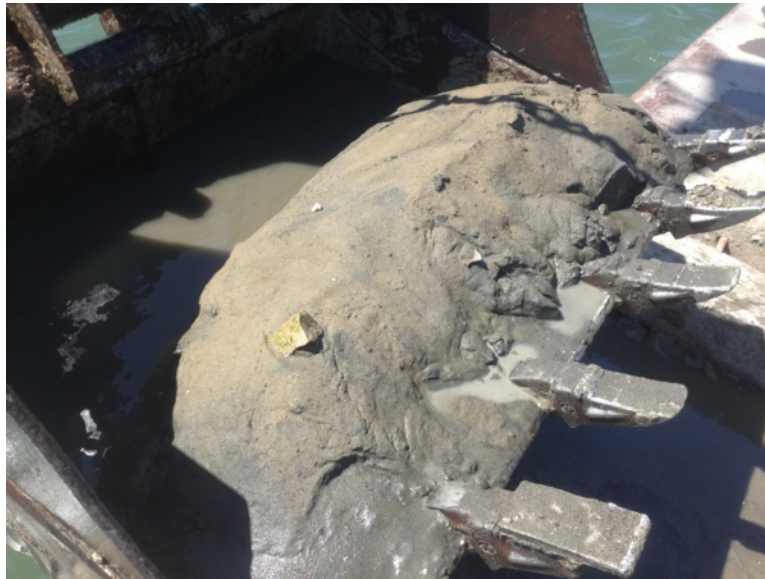
LOG OF SOIL PROFILE			FIELD DATA		LABORATORY DATA		
ELEVATION ft		Depth	DEPTH (ft)	SAMPLE NO.	SAMPLE TIP DEPTH (ft)	UNCONFINED COMP STRENGTH (psf)	MOISTURE CONTENT (%)
		Ground Surface Elevation 567 ft	0				
	FINE TO MEDIUM SAND, trace silt and gravel, occasional silty clay pockets and cobbles, brown and gray (SP)			GB1	2.0		
				GB2	5.0		
562.00		Bottom of Test Pit at 5 ft. (Terminate in sand soil)	5.0

TEST PIT COORDINATES
 E(x) Coordinate 13449266.0
 N(y) Coordinate 210601.0

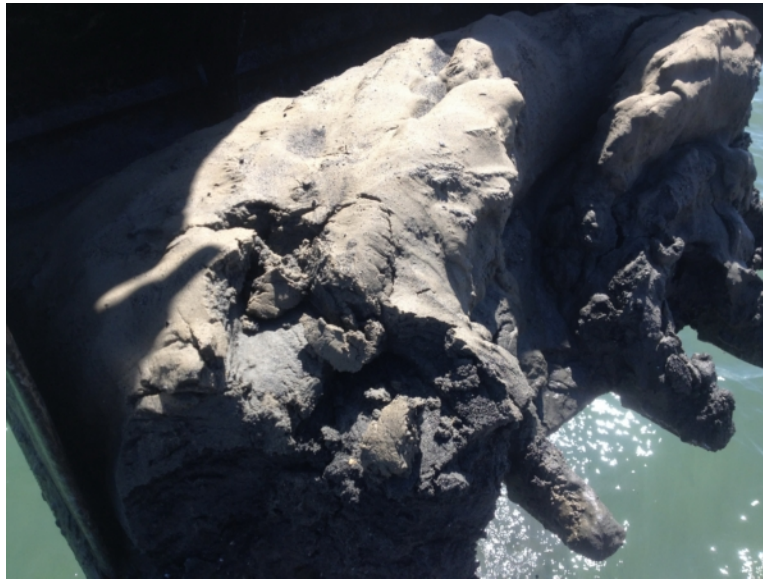
LOG OF SOIL PROFILE			FIELD DATA		LABORATORY DATA		
ELEVATION ft		Depth	DEPTH (ft)	SAMPLE NO.	SAMPLE TIP DEPTH (ft)	UNCONFINED COMP STRENGTH (psf)	MOISTURE CONTENT (%)
		Ground Surface Elevation 567 ft	0

FINE TO MEDIUM SAND, trace silt, gravel and cobbles, brown and gray (SP) (Engineer reported upper 2 feet of material appeared to be loose)	2.0	GB1	2.0		
			4.0	GB2	4.0		
560.50			6.5	GB3	6.5		
		Bottom of Test Pit at 6.5 ft. (Bucket refusal at 6.5 ft depth, terminate on possible cobbles)

TEST PIT COORDINATES
 E(x) Coordinate 13449369.0
 N(y) Coordinate 211419.0

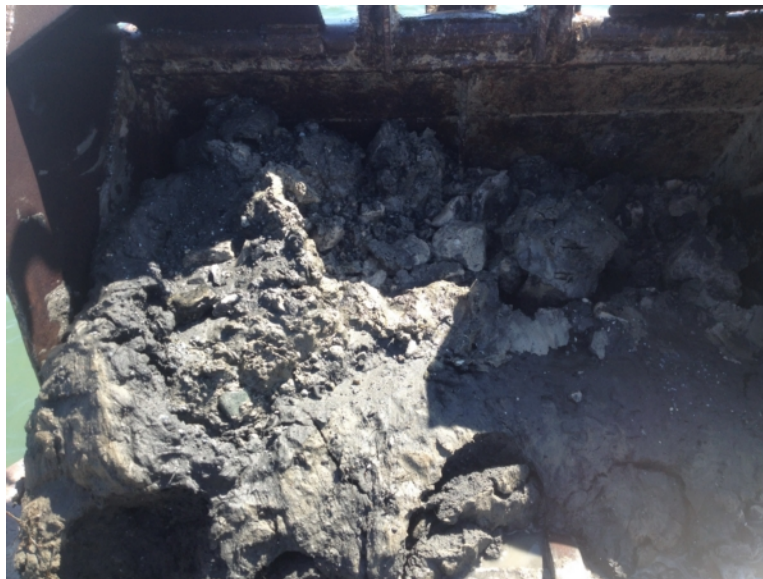
LOG OF SOIL PROFILE			FIELD DATA		LABORATORY DATA		
ELEVATION ft		Depth	DEPTH (ft)	SAMPLE NO.	SAMPLE TIP DEPTH (ft)	UNCONFINED COMP STRENGTH (psf)	MOISTURE CONTENT (%)
		Ground Surface Elevation 566 ft	0				
563.00

FINE TO MEDIUM SAND, trace silt and gravel, brown and gray (SP)		GB3	6.0		
		Bottom of Test Pit at 6 ft. (Bucket refusal at 6.0 ft depth, terminate on possible cobbles)	6.0

TEST PIT COORDINATES
 E(x) Coordinate 13449189.0
 N(y) Coordinate 212043.0

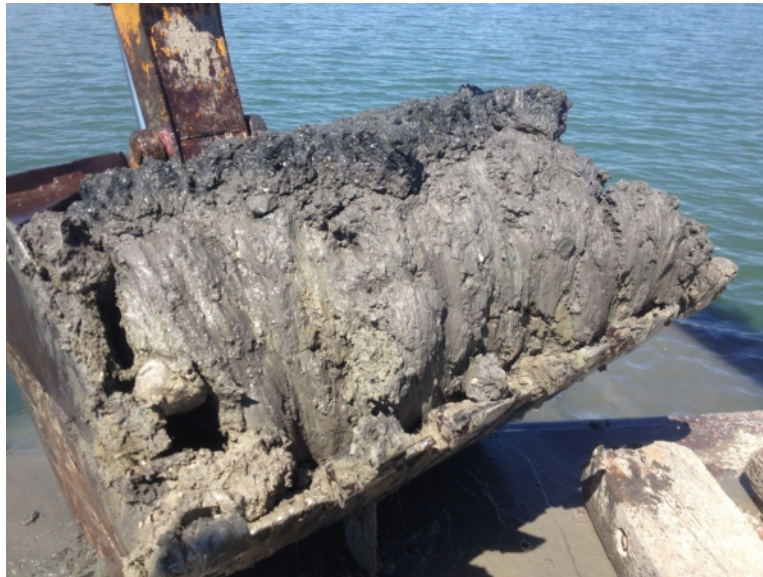
LOG OF SOIL PROFILE			FIELD DATA		LABORATORY DATA		
ELEVATION ft		Depth	DEPTH (ft)	SAMPLE NO.	SAMPLE TIP DEPTH (ft)	UNCONFINED COMP STRENGTH (psf)	MOISTURE CONTENT (%)
	Ground Surface Elevation 570 ft		0				
566.50	SILTY FINE SAND, trace gravel, brown and gray (SM)	3.5		GB1	3.5		
565.00	SILTY CLAY, trace sand and gravel, gray (CL) (samples disturbed so no hand penetrometer tests performed, excavator estimates medium to stiff consistency)	5.0		GB2	4.3		
			5	GB3	5.0		
561.50	Probe of material from 5 to 8.5 feet indicates silty clay soil	8.5					
	Bottom of Test Pit at 8.5 ft. (Bucket refusal at 8.50 ft depth, terminate in clay soil)

TEST PIT COORDINATES
 E(x) Coordinate 13448978.0
 N(y) Coordinate 212886.0

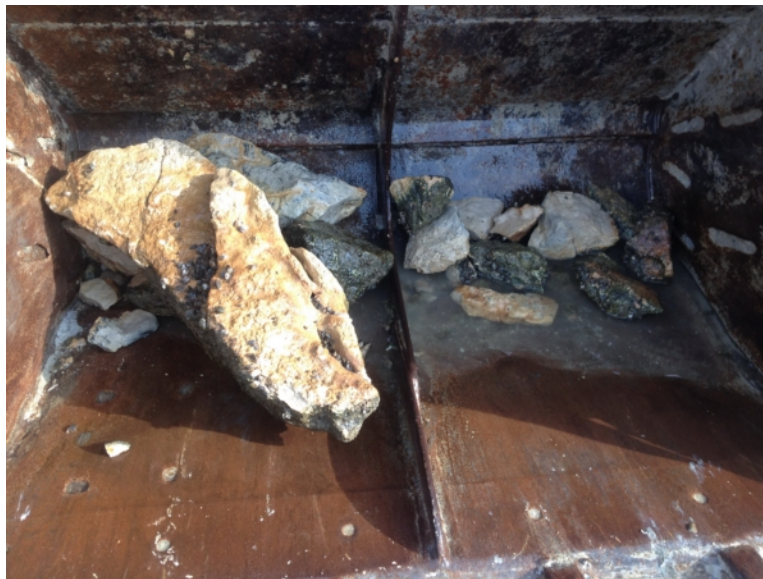
LOG OF SOIL PROFILE			FIELD DATA		LABORATORY DATA		
ELEVATION ft		Depth	DEPTH (ft)	SAMPLE NO.	SAMPLE TIP DEPTH (ft)	UNCONFINED COMP STRENGTH (psf)	MOISTURE CONTENT (%)
	Ground Surface Elevation 567 ft		0				
566.80

<p>Engineer reported BEDROCK COBBLES.</p>	0.2					
	Bottom of Test Pit at 0.2 ft. (Bucket refusal at 0.2 ft depth, possible top of bedrock)

TEST PIT COORDINATES
 E(x) Coordinate 13457093.0
 N(y) Coordinate 231576.0

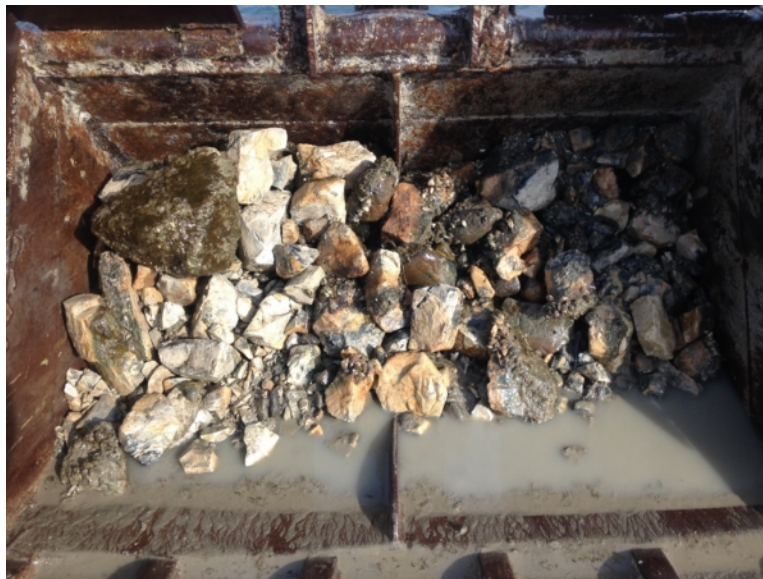
LOG OF SOIL PROFILE			FIELD DATA		LABORATORY DATA		
ELEVATION ft		Depth	DEPTH (ft)	SAMPLE NO.	SAMPLE TIP DEPTH (ft)	UNCONFINED COMP STRENGTH (psf)	MOISTURE CONTENT (%)
	Ground Surface Elevation 567 ft		0				
566.80	Engineer reported BEDROCK COBBLES.	0.2		GB1	0.2		
	Bottom of Test Pit at 0.2 ft. (Bucket refusal at 0.2 ft depth, possible top of bedrock)

TEST PIT COORDINATES
 E(x) Coordinate 13456620.0
 N(y) Coordinate 230333.0

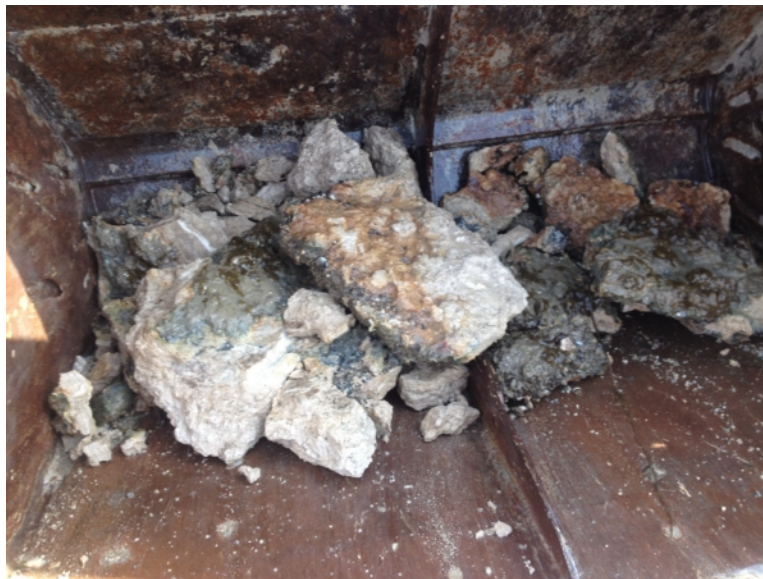
LOG OF SOIL PROFILE			FIELD DATA		LABORATORY DATA		
ELEVATION ft		Depth	DEPTH (ft)	SAMPLE NO.	SAMPLE TIP DEPTH (ft)	UNCONFINED COMP STRENGTH (psf)	MOISTURE CONTENT (%)
	Ground Surface Elevation 565 ft		0				
564.80

<p>Engineer reported BEDROCK COBBLES.</p>	0.2					
	Bottom of Test Pit at 0.2 ft. (Bucket refusal at 0.2 ft depth, possible top of bedrock)

TEST PIT COORDINATES
 E(x) Coordinate 13456623.0
 N(y) Coordinate 229910.0

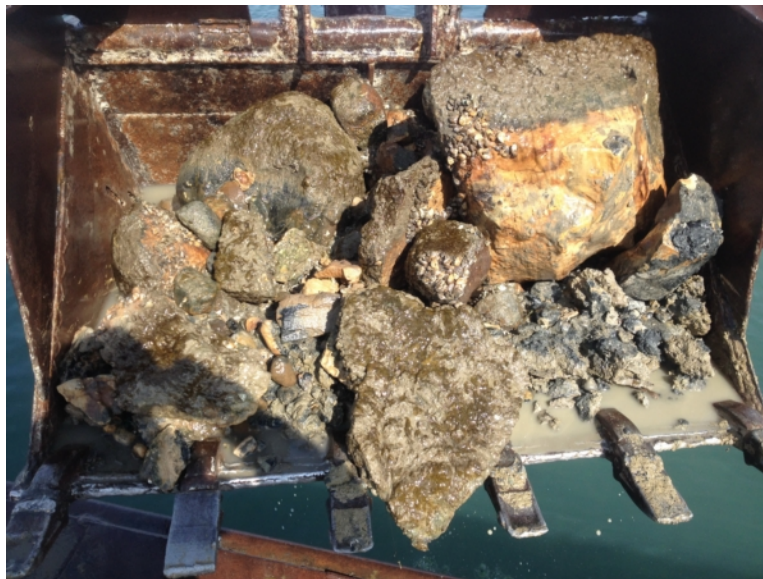
LOG OF SOIL PROFILE			FIELD DATA		LABORATORY DATA		
ELEVATION ft		Depth	DEPTH (ft)	SAMPLE NO.	SAMPLE TIP DEPTH (ft)	UNCONFINED COMP STRENGTH (psf)	MOISTURE CONTENT (%)
	Ground Surface Elevation 565 ft		0

<p>SILTY SANDY CLAY, trace to some gravel and cobbles, brown (CL)</p>	5.0		GB3	5.0		
560.00			5				
	Bottom of Test Pit at 5 ft. (Terminate in clay soil)

TEST PIT COORDINATES
 E(x) Coordinate 13456799.0
 N(y) Coordinate 229363.0

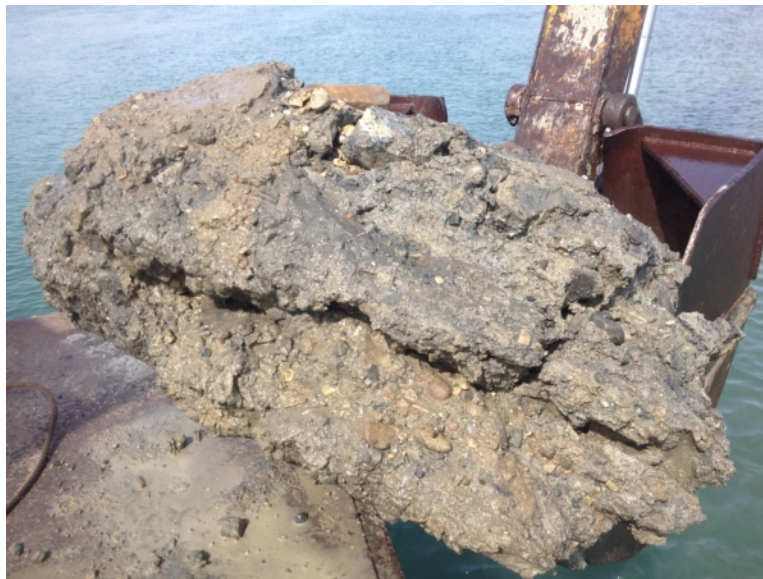
LOG OF SOIL PROFILE			FIELD DATA		LABORATORY DATA		
ELEVATION ft		Depth	DEPTH (ft)	SAMPLE NO.	SAMPLE TIP DEPTH (ft)	UNCONFINED COMP STRENGTH (psf)	MOISTURE CONTENT (%)
		Ground Surface Elevation 566 ft	0				
563.50

SILTY CLAY, trace sand, gravel and cobbles, occasional sand pockets, gray (CL)		GB2	4.5		
		Bottom of Test Pit at 4.5 ft. (Terminate in clay soil)	4.5

TEST PIT COORDINATES
 E(x) Coordinate 13457220.0
 N(y) Coordinate 228633.0

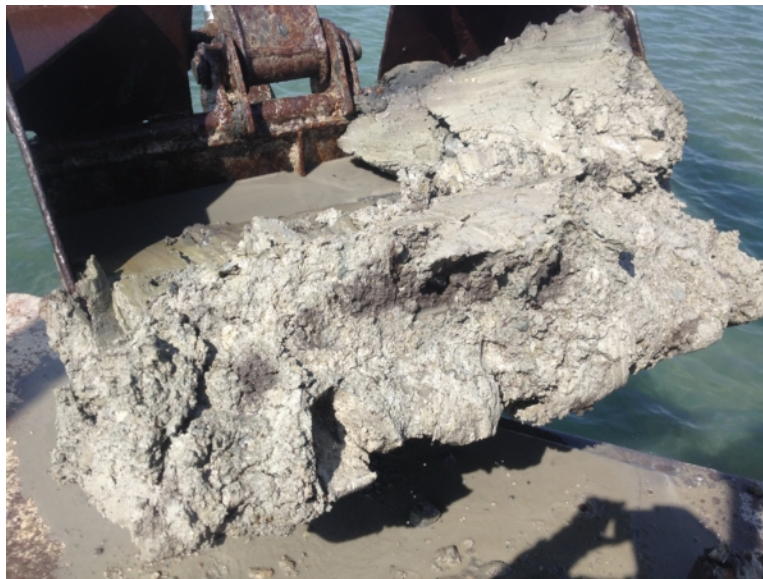
LOG OF SOIL PROFILE			FIELD DATA		LABORATORY DATA		
ELEVATION ft		Depth	DEPTH (ft)	SAMPLE NO.	SAMPLE TIP DEPTH (ft)	UNCONFINED COMP STRENGTH (psf)	MOISTURE CONTENT (%)
	Ground Surface Elevation 568 ft		0				
565.00	SILTY FINE SAND, trace to some clay, trace gravel, gray (SM)	3.0		GB1	3.0		
563.00	SILTY CLAY, trace to some sand, trace gravel, mottled brown and gray to gray (CL)	5.0		GB2	4.0		
				GB3	5.0		
	Bottom of Test Pit at 5 ft. (Terminate in clay soil)		5

TEST PIT COORDINATES
 E(x) Coordinate 13457611.0
 N(y) Coordinate 228759.0

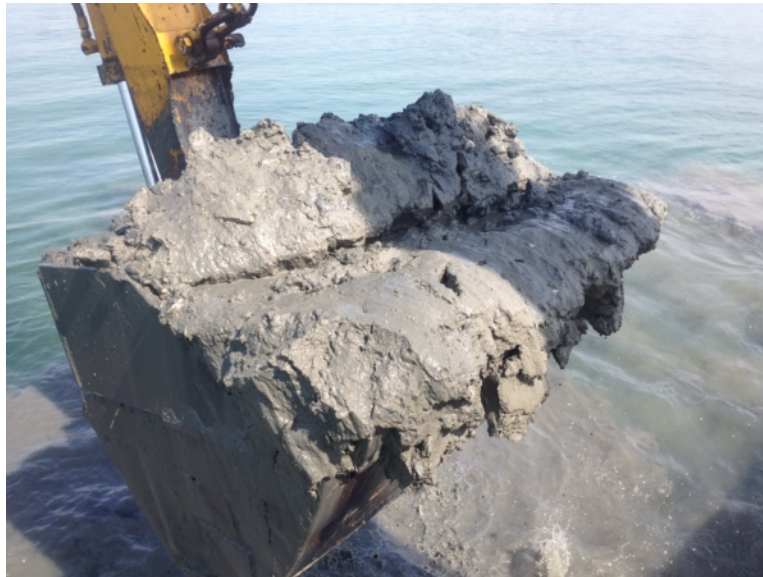
LOG OF SOIL PROFILE			FIELD DATA		LABORATORY DATA		
ELEVATION ft			DEPTH (ft)	SAMPLE NO.	SAMPLE TIP DEPTH (ft)	UNCONFINED COMP STRENGTH (psf)	MOISTURE CONTENT (%)
		Ground Surface Elevation 567 ft	0				
563.00

Probe of material from 6 to 7.5 feet indicates silty clay soil	7.5	GB3	7.5		
		Bottom of Test Pit at 7.5 ft. (Terminate in sand soil)

TEST PIT COORDINATES
 E(x) Coordinate 13457772.0
 N(y) Coordinate 228506.0
